Structural Condition Assessment on Boxborough Police Station Boxborough, Massachusetts

Date: April 17, 2023
To: Ellen Light, AIA LEED AP BD&C - Context Architecture
From: Carmine Guarracino, P.E.; Stephanie Snider, E.I.T.
Project: Boxborough Police Station
Location: Boxborough, MA
Reference: Structural Conditions Report

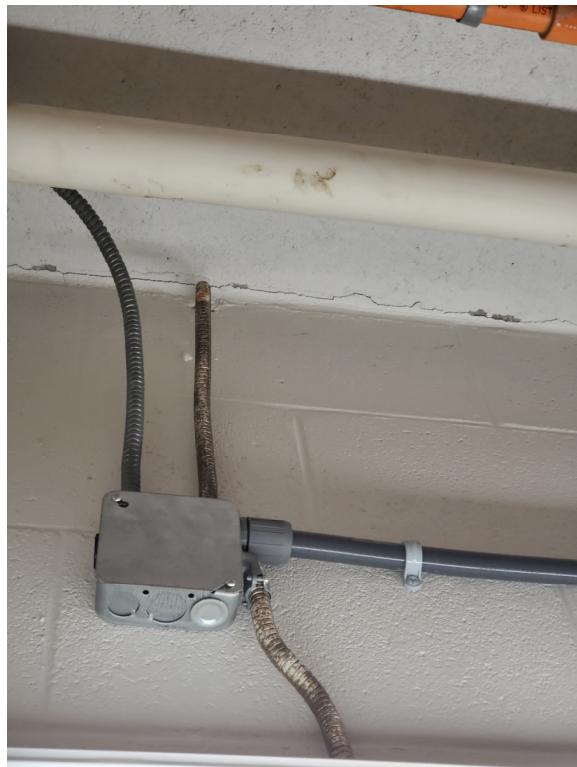
Photo 1.

Overall, the existing building is in very good condition. No visible cracking or water damage can be seen at the wood framed upper level. The lower level was also in good condition structurally. Some cracks were found within mechanical closet, see photo 1, but it was determined that the wall was non-load bearing. The cracking is most likely due to the compressible fill between the top of wall and the plank and which is not a structural concern. Additionally, small area of spalling was noted on the edge of the plank within the locker room area, see photo 2. This appears to be superficial and does not cause a structural concern. Photo 3 shows the telecommunication equipment currently installed at the station. It is assumed these were installed according to applicable codes and the building was checked for additional loading at the time of installation. There were no additional items noted during the visit.
