**Town of Boxborough
Levi Wetherbee Farmhouse Stabilization
484 Middle Road
Boxborough, Massachusetts 01719**

**Schematic Design Submission
CBI Project No. 17159
December 1, 2017**

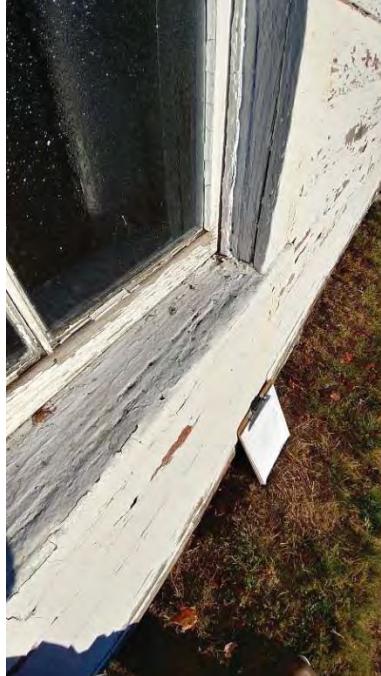
Close up of the window sill and pane. Note the missing glazing compound leaving the muntin seam exposed. The wood trim has deteriorated in areas causing gaps.

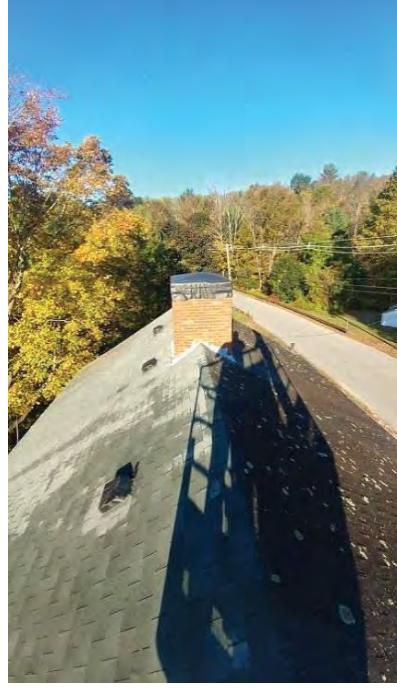
6

View of the brick masonry chimney and shingle roofing. Note the visible algae growth on the north side.
7

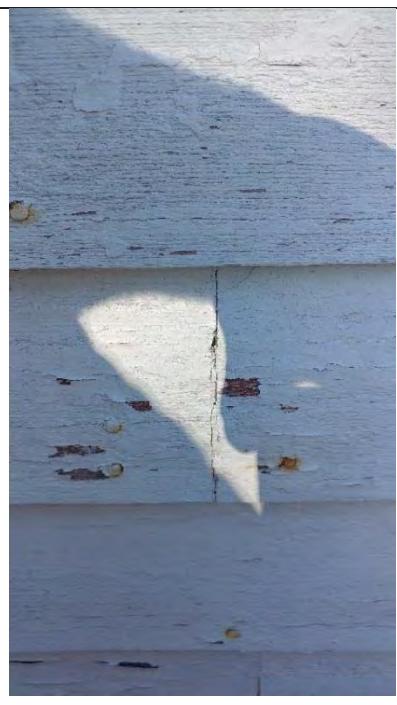
Close up of the cracked butt end of the wood clapboard siding

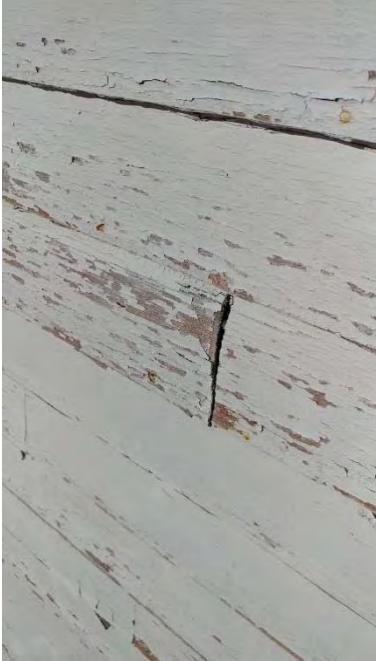
8

Close up of the warped butt end of the wood clapboard siding beginning to pull away from the sheathing.
9

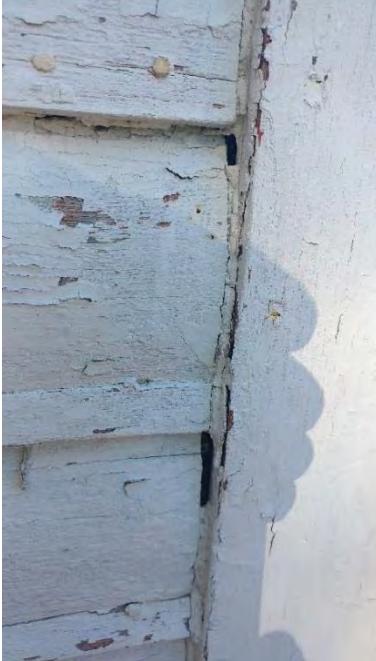
Close up of missing sealant where the clapboard butts against the corner trim.

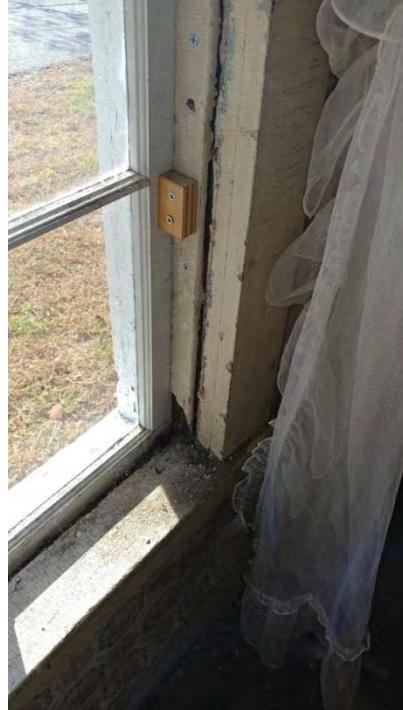
10

Interior window sill, the lower sash is fastened shut with screws and wood blocks.
11

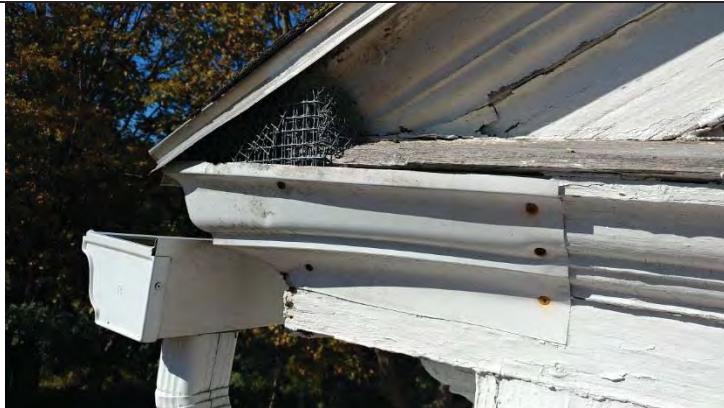
Formed metal repair with exposed fasteners at west elevation gable end return.

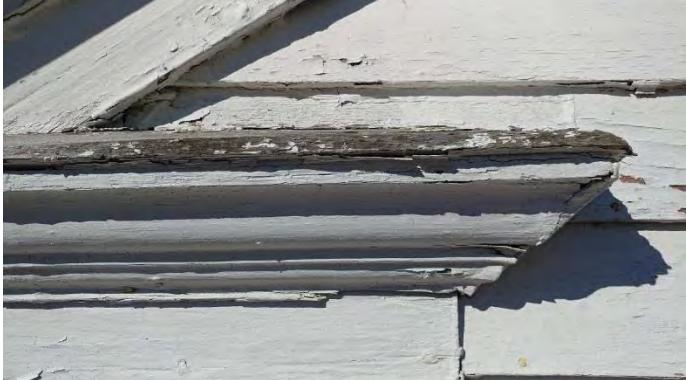
12

Close up view of the deteriorated wood gable end return molding on the east gable end return.
13

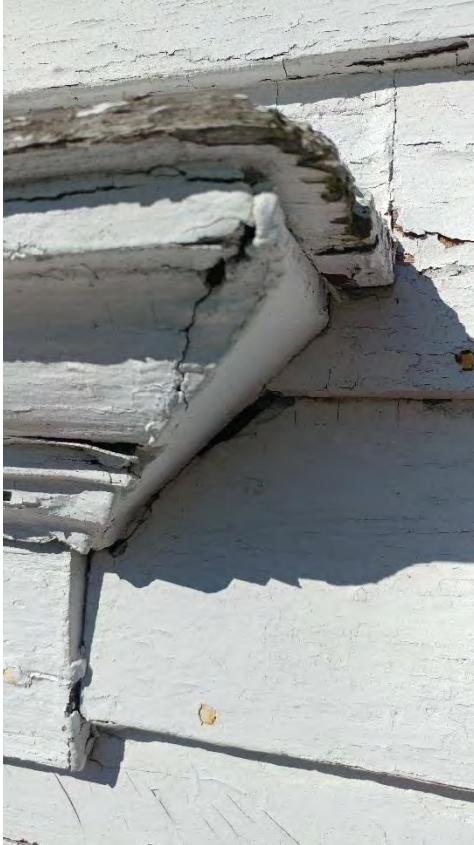
Close-up side view of the deteriorated wood eave molding on the east gable end return.

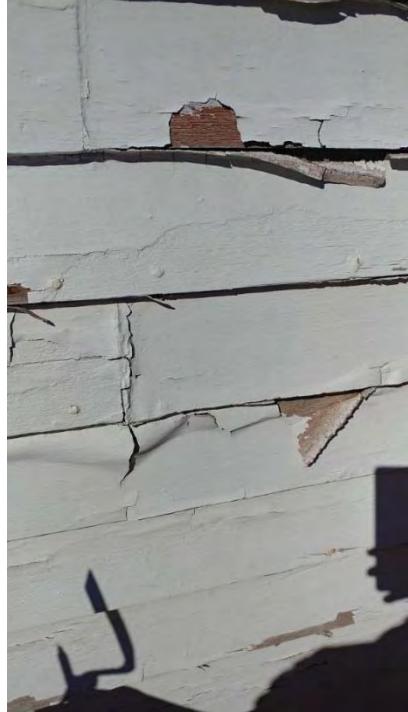
Close up of the peeling and delaminated paint.
14

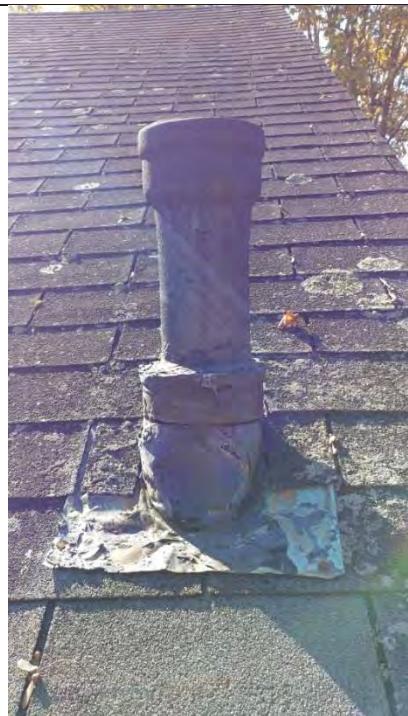
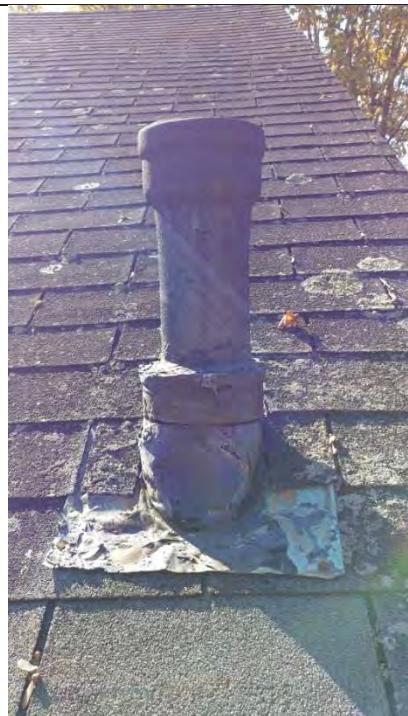
Cast iron pipe penetration deteriorated copper flashing and asphaltic roof mastic.
15

Cast iron pipe penetration deteriorated copper flashing and asphaltic roof mastic.

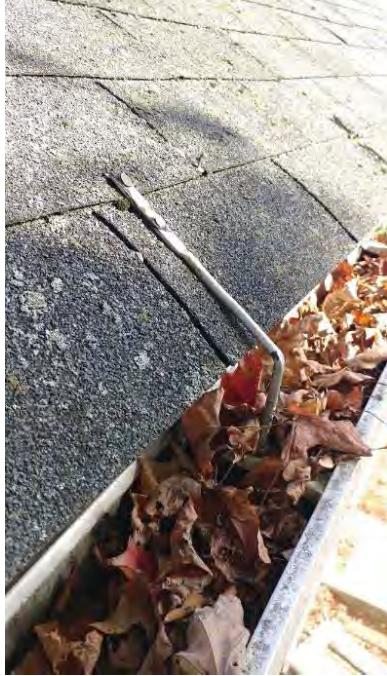
Aluminum gutter with hanger rods fastened directly through the shingle roofing.
	17

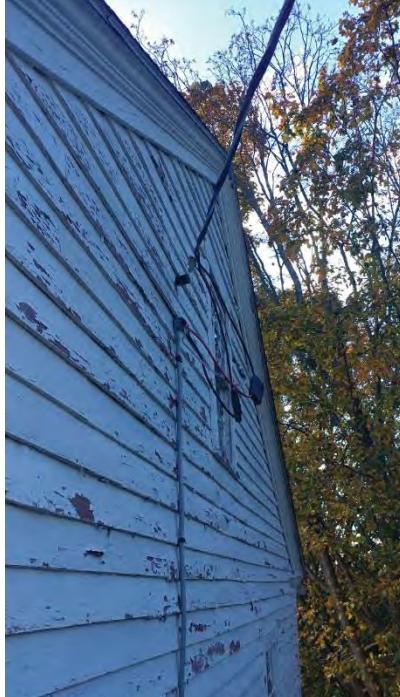
West elevation electrical hook up to be disconnected during work.

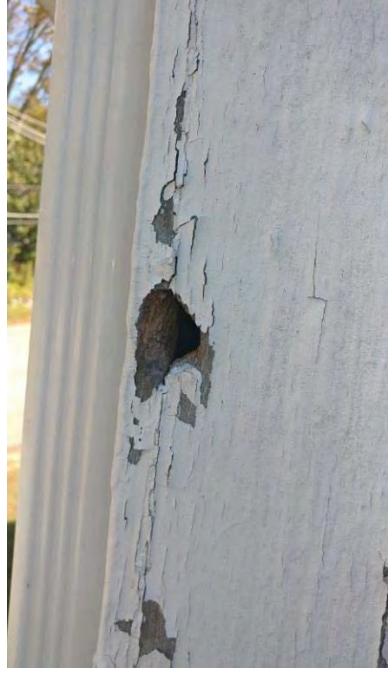
18

Close up view of one of the many holes within the wood board corner trim.
19

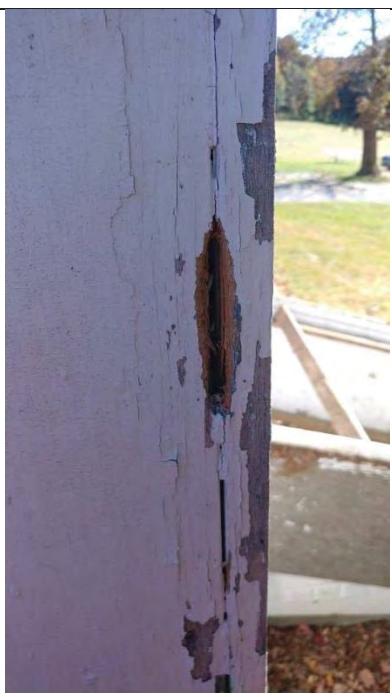
Another close-up view of one of the holes in the wood board corner trim.

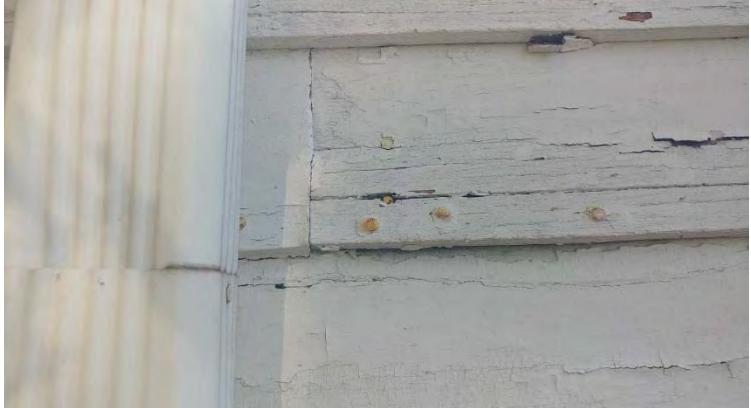
20

Views of cracked and split clapboard siding with a high concentration of fasteners.
21

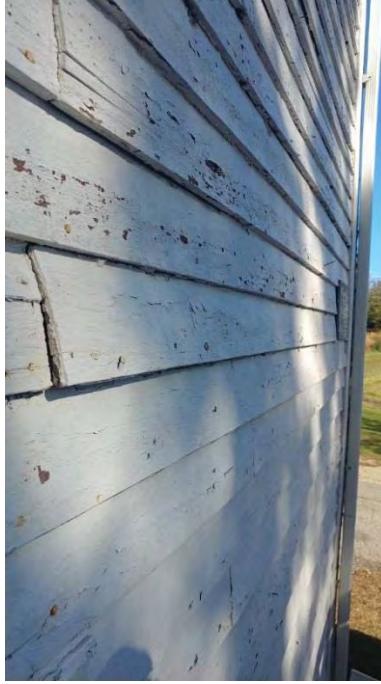
Areas of cracked, split, cupped, and bowed clapboard siding. Attempts have been made to fasten it back in place.

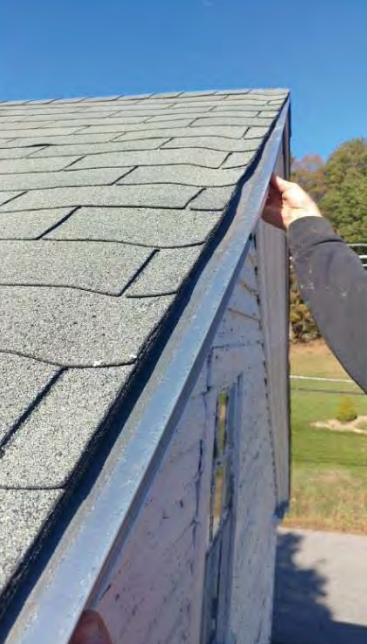
Loose and detached aluminum rake edge.
22

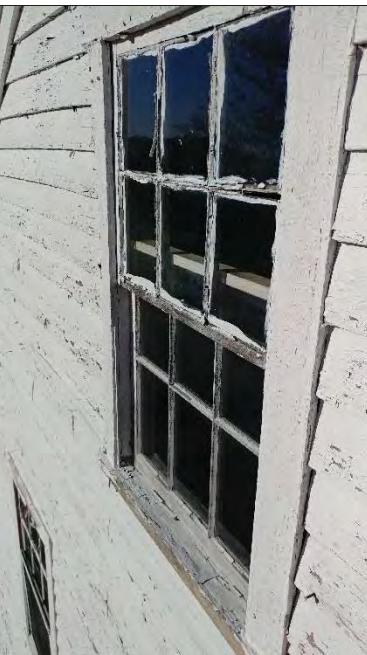
Overall exterior window view of missing glazing compound and paint coating, exposing the bare wood.

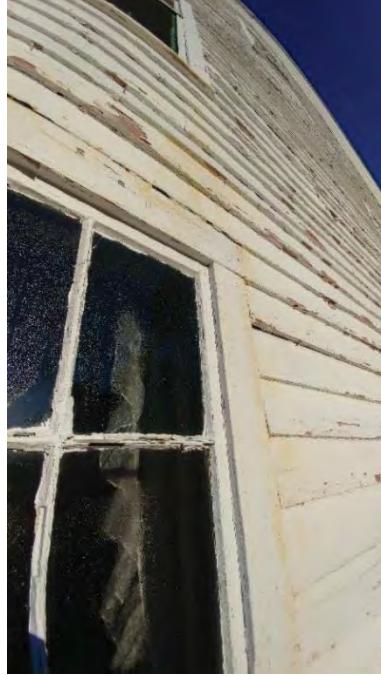
Exterior close up view of muntins with deteriorated wood and missing glazing compound.
	25

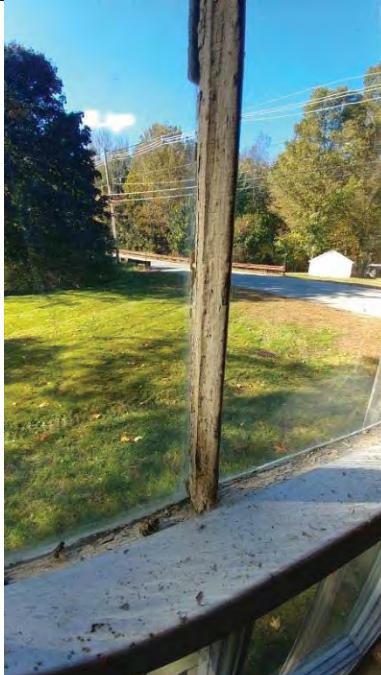
Interior close up view of muntins with deteriorated wood and weathered paint; note the glass appears newer as it does not include any distortions.

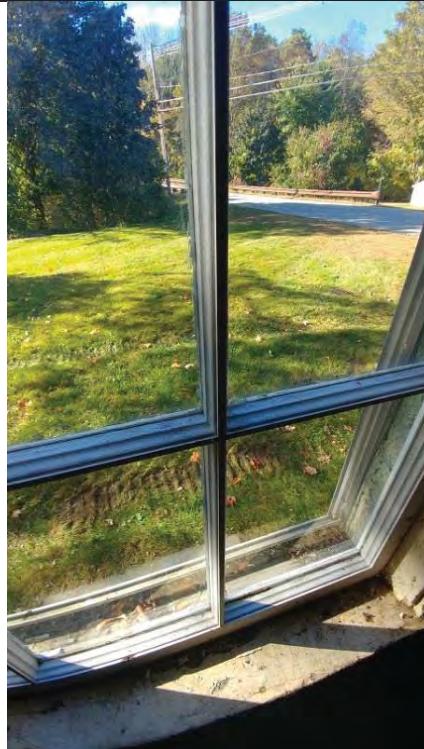
26

Close up view of a window replica, the material appears not as aged and the muntin profiles are different than the other windows.

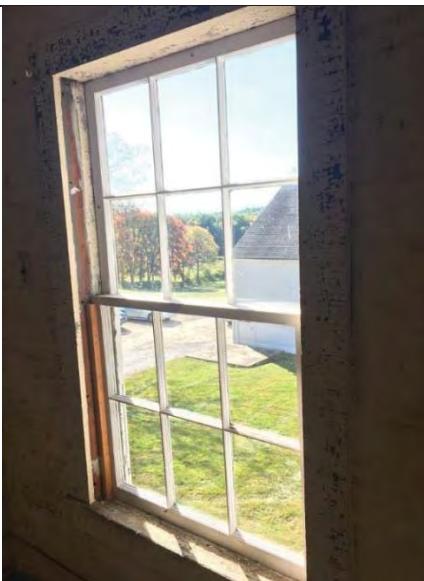
27

Overall view of a window replica. Note missing jamb trim and the exposed underlying bare wood.

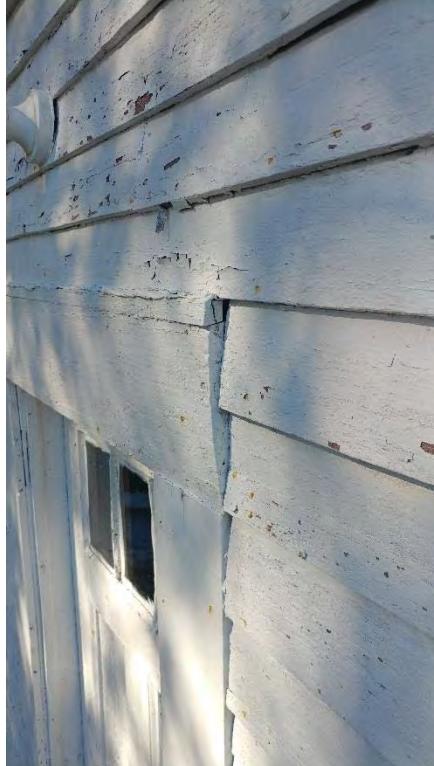
28

Exterior close up of the entry head trim along the south elevation. Notice the trim in bowing and pulling away from the sheathing.

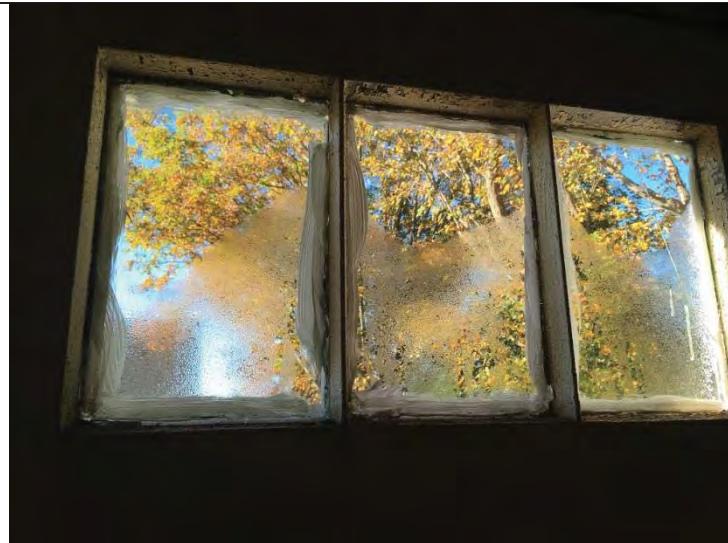
29

View of the vision panels on the south door leaf. Notice the glass is distorted.

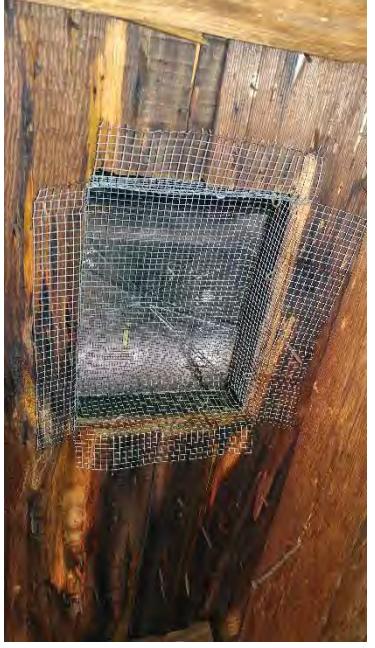
30

A photograph showing the underside of a roof vent. The vent is a dark, rectangular metal structure with a fine mesh screen over it, mounted on a wooden roof. The surrounding area is made of wooden joists and rafters.	Underside view of the roof vent along the south side roof.
31

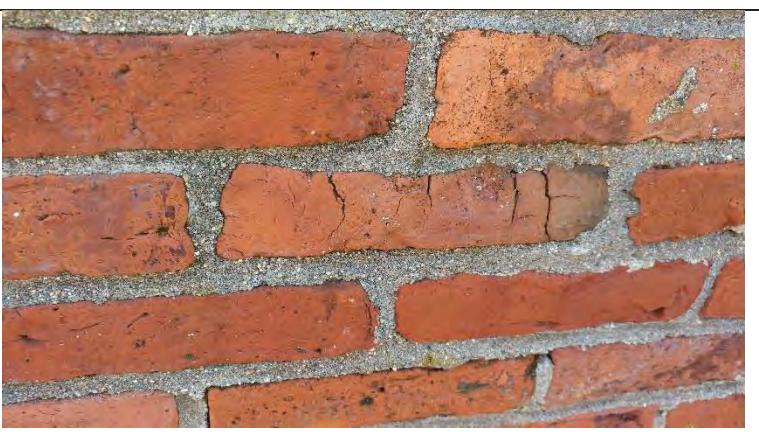
A photograph showing a close-up of a brick chimney. The bricks are red and appear to be made of a rough, textured material. There are several horizontal rows of bricks, with visible mortar between them. Some of the bricks show signs of cracking and wear.	Close up of the cracked brick on the chimney above the roof.

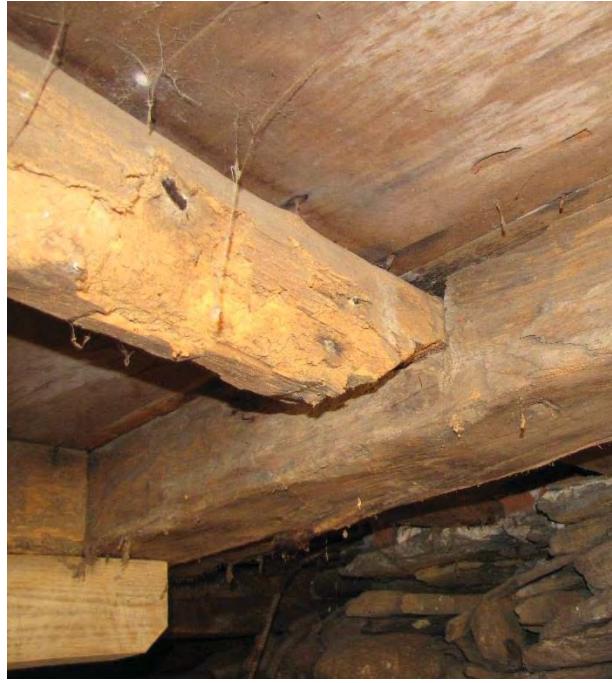
03

<p>Photo of damaged joist tenon at longitudinal beam – first-floor framing. The damage is likely due to insect infestation.</p>
04

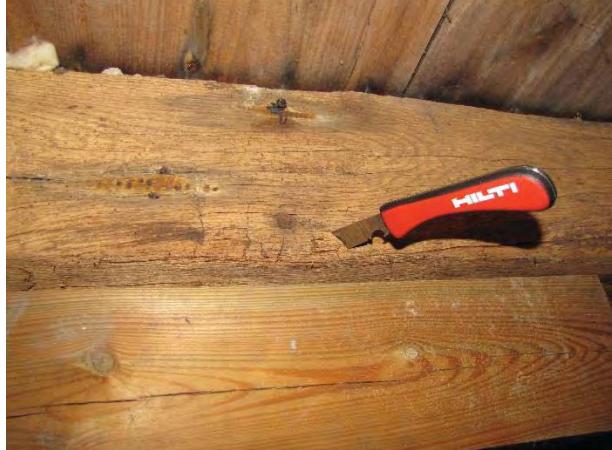
<p>Photo similar to Photo 02. Note presence of supplementary wood member below damaged beam.</p>

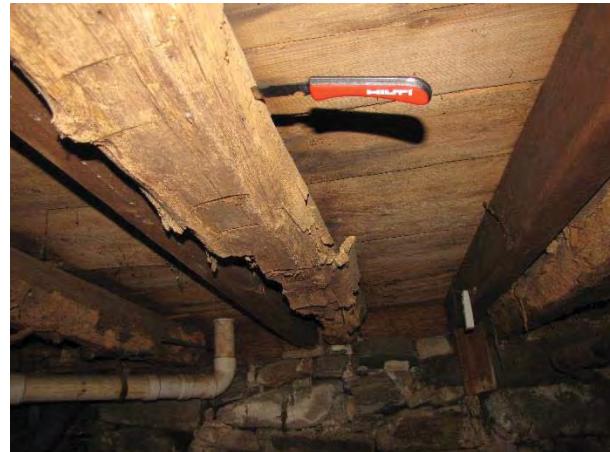
Photo similar to Photo 05, at northwest portion of first-floor framing. Note sistered wood member adjacent to damaged joist.
07

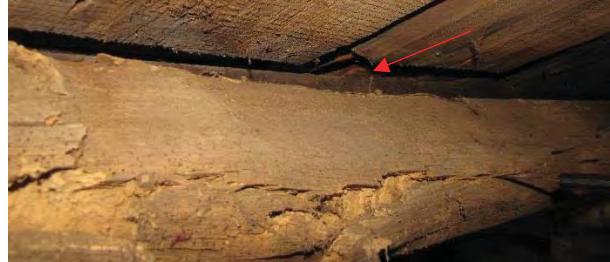
Photo of severely damaged first-floor joist. Note effects of insect damage, and note gap between floor boards and wood joist (red arrow).

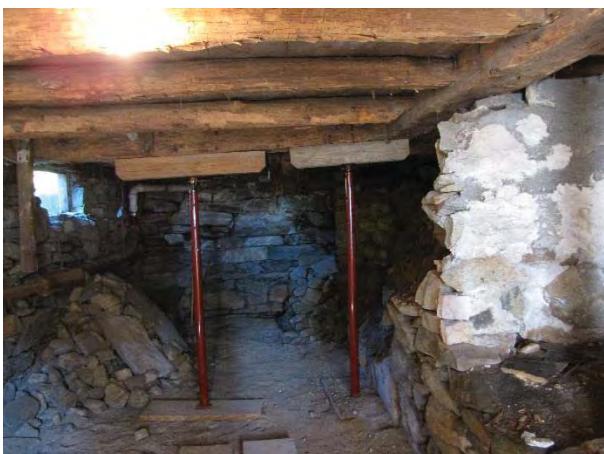
A photograph of a basement or crawlspace area. It shows a large pile of rubble to the left, remnants of a collapsed central stone foundation wall. Two red vertical poles provide temporary shoring for a wooden beam.	Photo of temporary shoring at first-floor beam. Note rubble pile to the left – remnants of collapsed central stone foundation wall.
10

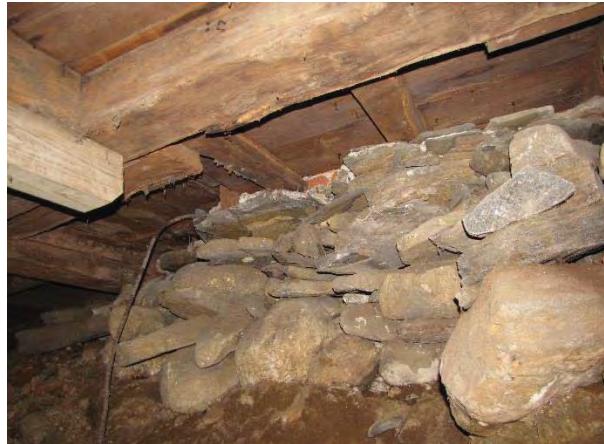
A photograph showing a view from under a floor. A large, damaged central stone wall is visible, with several large stones missing. The floor joists above are visible, and some debris is scattered on the ground.	Photo of first-floor framing at damaged central stone wall.

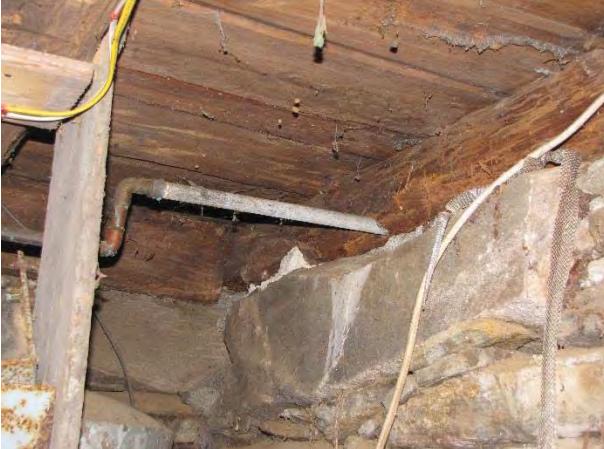
13

A photograph showing a close-up view of a wooden sill in a cellar. The wood appears dark and heavily damaged, likely from moisture. The sill is supported by a metal bracket and sits on a stone foundation wall. There are some yellow and green wires visible in the background.	Photo of moisture-damaged sill at southeast portion of cellar.
14

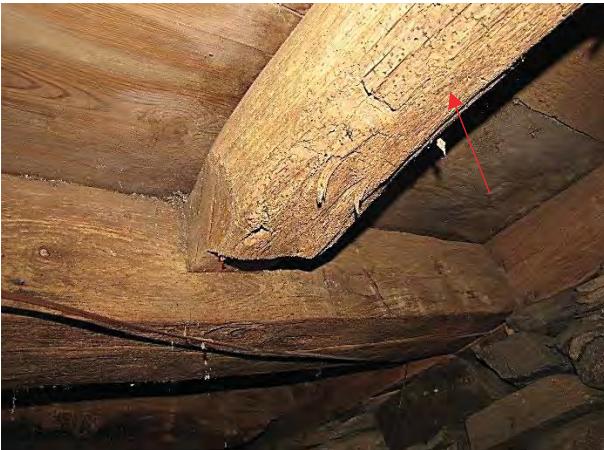
A photograph showing a close-up view of wooden framing at a corner. A red arrow points to a specific area of damage or insect infestation on the wood.	Photo of insect damage at first-floor framing (red arrow).

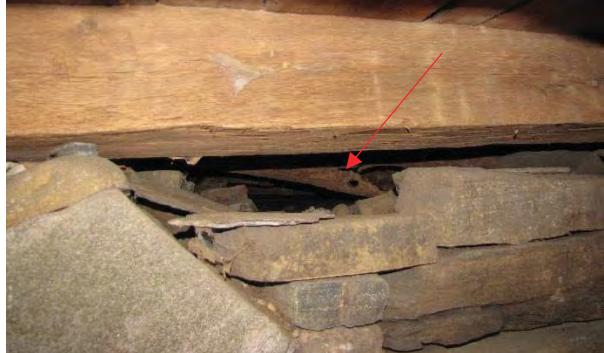
16

A photograph showing a section of failed first-floor framing. A red arrow points to a collapsed floor joist resting on a stone foundation wall. The framing above is visible, showing signs of decay and damage.	Photo of failed first-floor framing at central northern portion at central stone foundation wall.
16-A

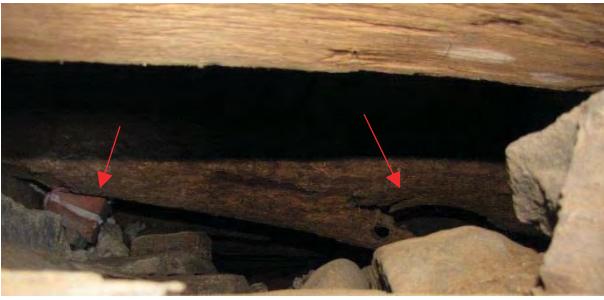
A close-up photograph of the failed first-floor framing from Photo 16. Two red arrows point to specific areas of concern: collapsed chimney bricks and a collapsed floor joist.	Close-up view of conditions in Photo 16. Note failed chimney bricks and collapsed floor joist (red arrows).
17

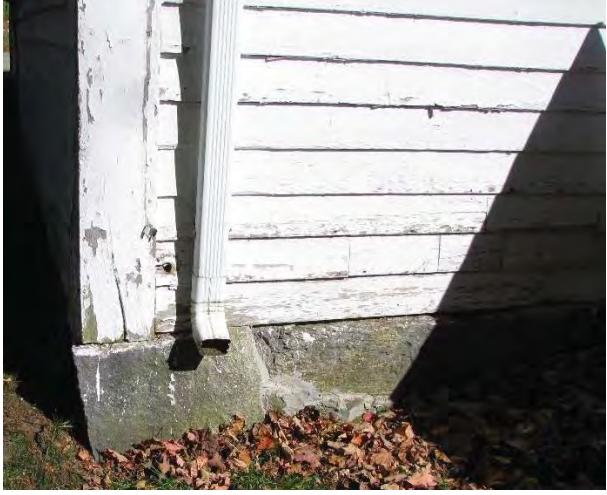
18

<p>Photo of corner post support at foundation corner. Note skew of foundation corner stone.</p>
19

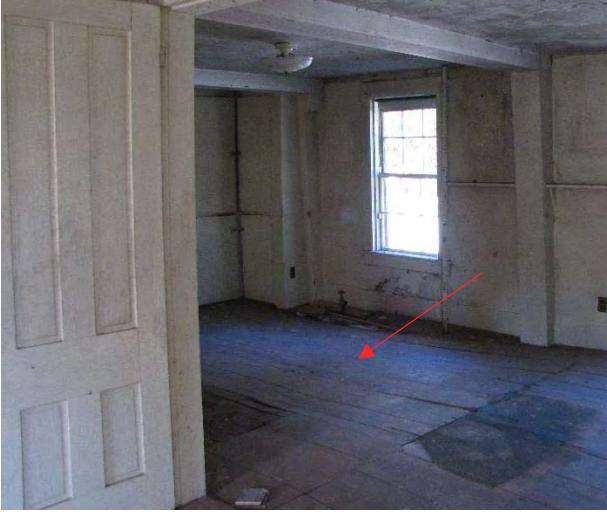
<p>Photo of deflected first floor portion at north central framing over stone foundation below (red arrow).</p>

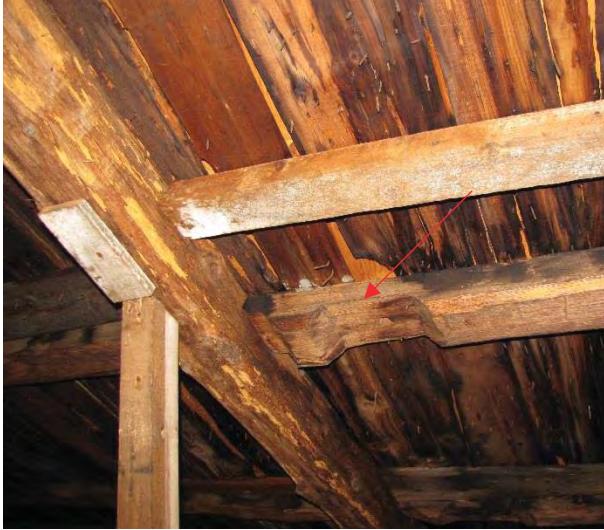
23

A photograph showing the underside of a wooden roof or floor joist system. A horizontal wooden beam is visible, and a red arrow points to a small, irregularly shaped piece of wood or debris resting on it, indicating a construction mistake.	Photo of original construction mistake at wind girt (red arrow).
24

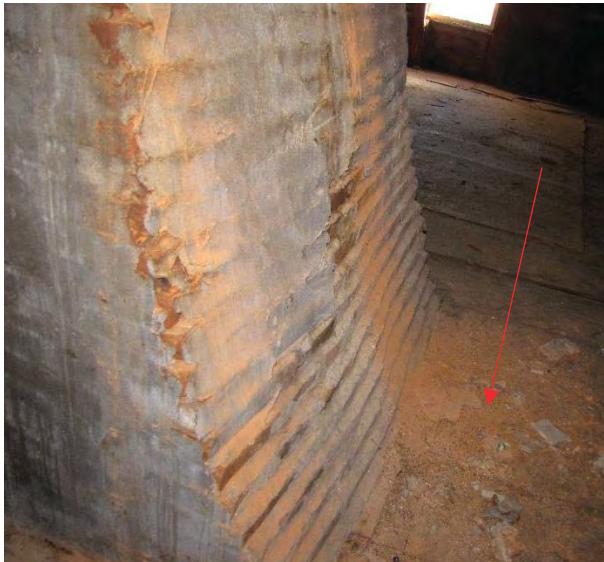
A photograph of a central chimney. The left side of the chimney is covered in a dark, textured parge coat. The brickwork on the right side is visible and appears to be eroding, with a red arrow pointing to a specific brick that has suffered significant damage.	Photo of eroding bricks (red arrow) and parge coat at central chimney.

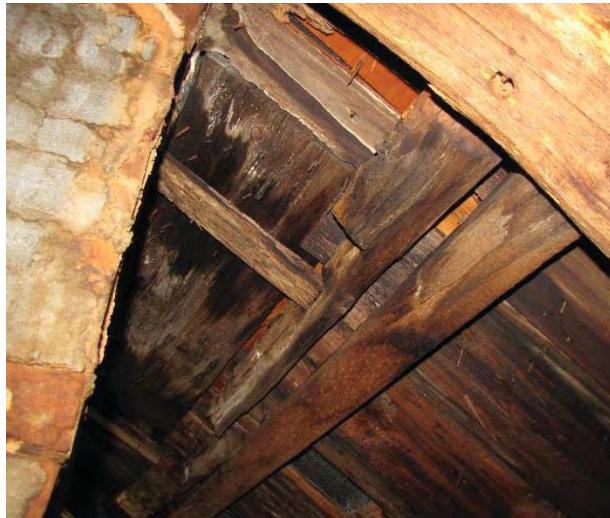
25

Photo of damaged roof framing south of brick chimney.
