PUBLIC SAFETY PROJECT FEASIBILITY STUDY

1300 MASSACHUSETTS AVENUE BOXBOROUGH, MASSACHUSETTS

Prepared For:
TOWN OF BOXBOROUGH, MA

EXISTING CONDITIONS REPORT

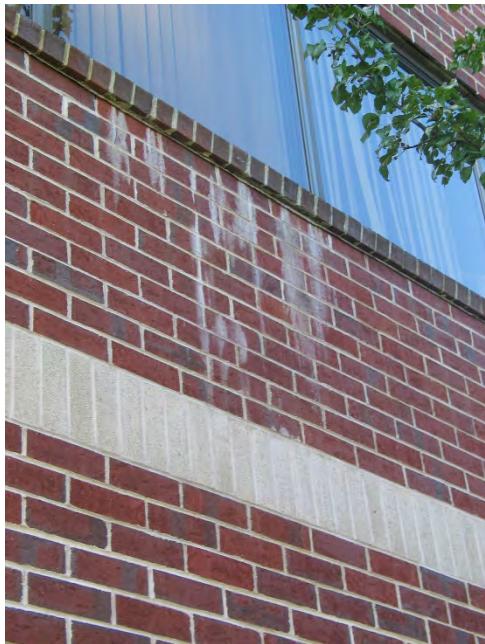
Wall Condition: Good – Brick appeared to be in good condition. Two areas of efflorescence were observed under the second floor window sills on the north and east façades (photo 2). Deteriorated mortar was observed in a few locations, primarily under the second floor window sills on the north façade (photo 3). Brick window sills at several corner locations also required repointing with bricks visibly loose (photo 4). Some damaged bricks were observed at the corner of the building near the loading dock (column A,1) (photo 5). Lichen and moss were observed on first floor window sills, primarily on the north and west elevations (photo 6).

2 - Efflorescence below window sills

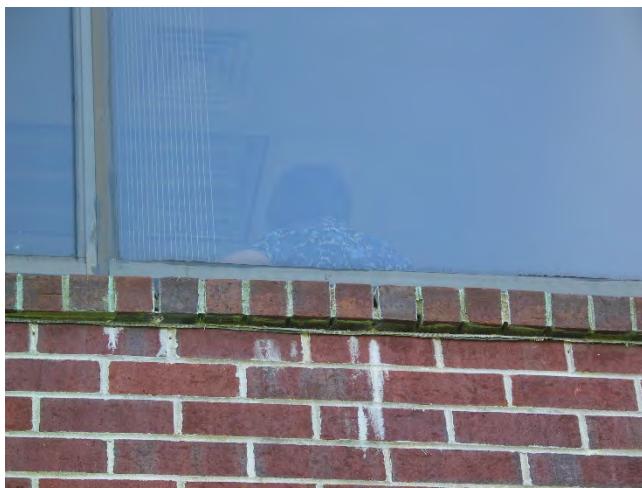
3 - Deteriorated mortar joints and efflorescence

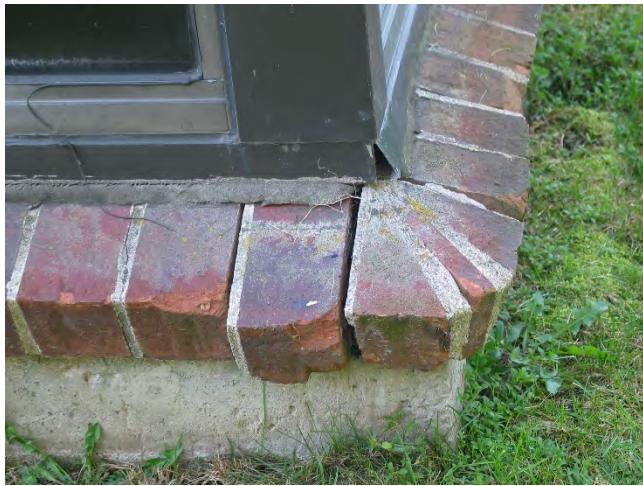
4 - Brick window sill requiring repointing

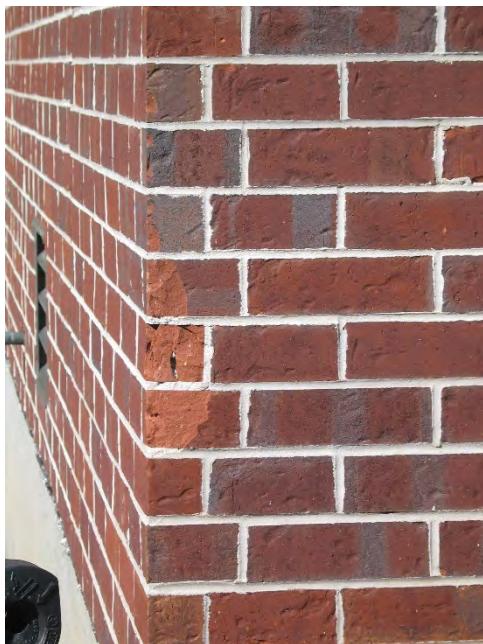
5 - Damaged bricks at building corner near loading docks

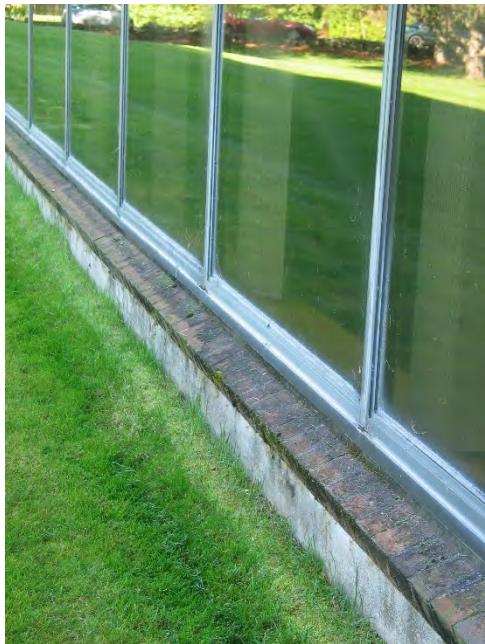
6 - Lichen and moss growing on masonry and concrete wall

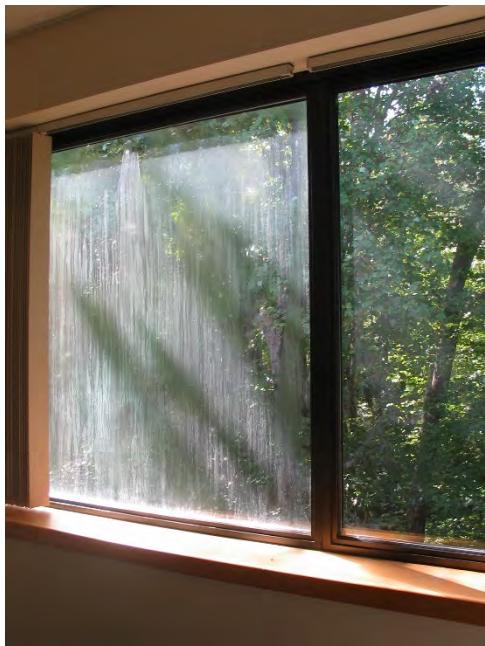
A history of water infiltration was observed around existing storefront ribbon windows wrapping the façade on both levels. Etched and/or fogged glass was observed in multiple locations indicating seals on the insulated glass units (IGUs) at the ribbon windows have failed. Storefront at the main lobby entrance appears to be non-thermal with only single paned glazing. With a major renovation, all storefront windows should be replaced with a new, more energy efficient storefront system.

Window Conditions: Fair – Etched/fogged glass indicative of failed window seals were observed in multiple locations (photo 7).

7 – Etched/fogged glass indicative of failed window seals

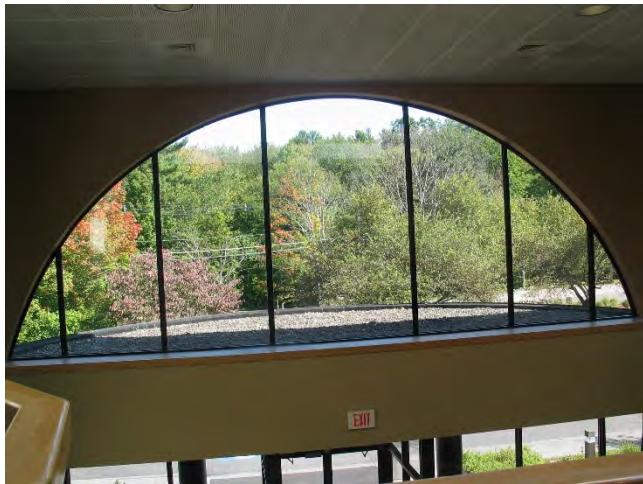
8 - Stone ballasted rubber roof over main entrance canopy visible through storefront window

The existing stone ballasted roof should be replaced with a new adhered membrane and roof insulation installed to meet current code requirements. Removing the stone ballast will address some structural issues which are addressed in the structural report.

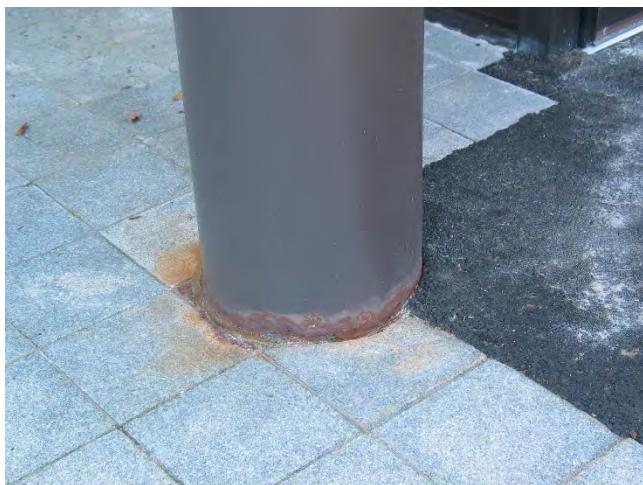
Other Ext. Issues: The base of column covers at the main entrance canopy are corroded (photo 9).

9 - Corroded column at main entrance canopy

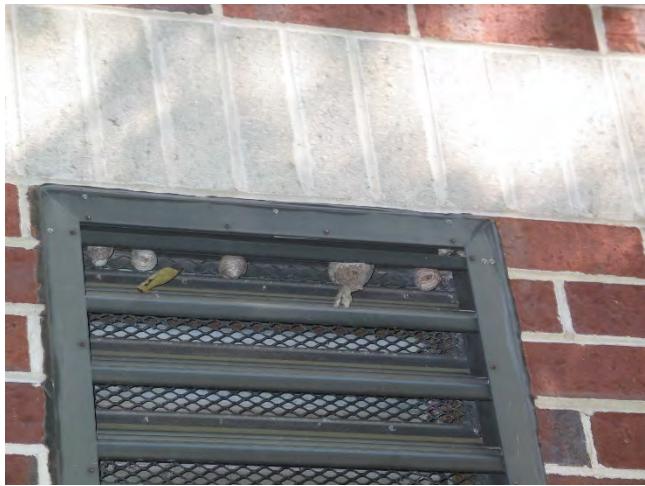
10 - Example of louver with no visible flashing or weeps at head

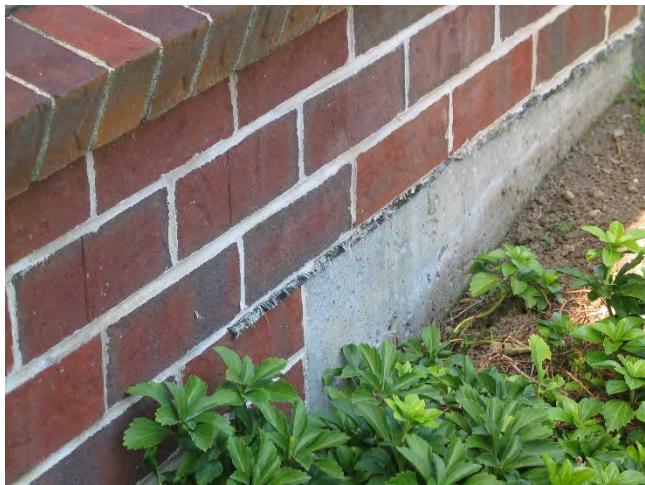
Flexible membrane thru-wall flashing was observed penetrating the masonry veneer throughout the main building and the fire pump house across the street. Flashing was observed in numerous locations including at window/door heads/sills, at wall base above concrete foundation walls, at main entrance canopy intersection with wall, etc. Flashing was not observed at some louver locations (photo 10). At almost all visible locations, the membrane protruding the wall appeared to be a rubberized asphalt membrane. Rubberized asphalt membranes are not UV-stable and therefore, when installed, should be held back from the building façade and terminated with a metal drip edge. No metal drip edges were visible at either the main building or pump house. Instead in all visible locations, the rubberized asphalt membrane protrudes from the building façade and has degraded with the asphalt having melted and dripped off, in some cases staining the wall below (photos 11, 12).

The condition of the visible flashing raises questions to the condition of the concealed flashing within the wall. Rubberized asphalt membranes have melting points above which the asphalt can melt off the membrane. It is possible for the temperature within masonry wall cavities to exceed this melting point temperature causing the asphalt to melt and flashings to fail. Conditions of the flashings in this case cannot be verified without removing bricks to inspect the wall cavity.

11 - Degraded flexible membrane thru-wall flashing where masonry meets concrete foundation wall

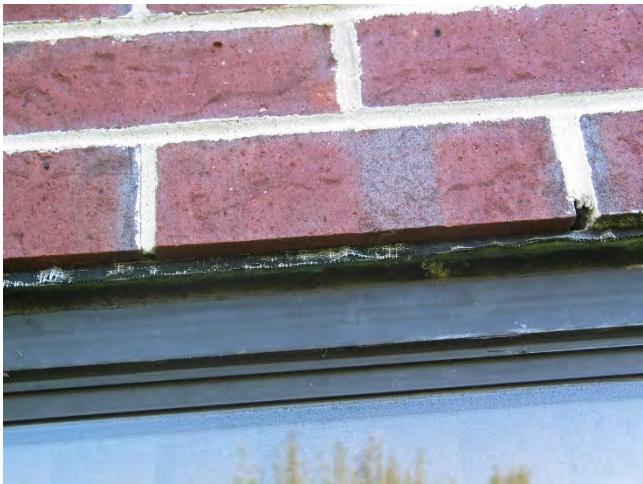
12 - Degraded flexible membrane thru-wall flashing at window head

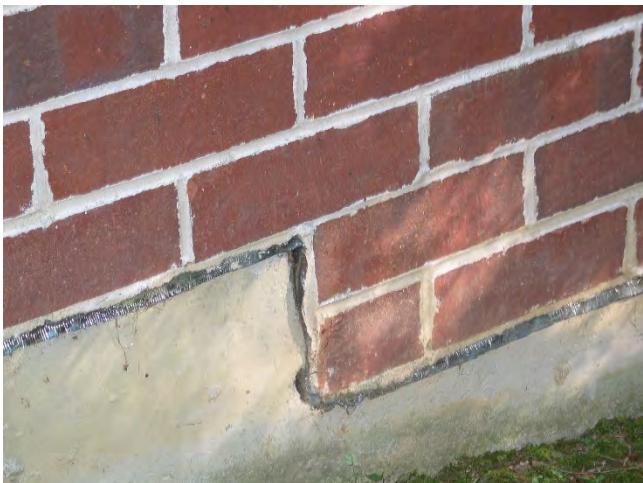
Stepped flexible membrane flashing was observed at the stepped foundation wall where the surrounding exterior grade is above finished floor level. Flashing appeared to run horizontally along the foundation wall, turning down vertically at the foundation wall step and then turning horizontally at the lower foundation wall elevation (photo 13). This is not the preferred method of installing stepped flashing. To form a step, the end of flashing at the highest elevation should be extended past the step, to overlap the flashing below by a minimum of 4 inches, and turned up to form an end dam. The lower piece of flashing should be formed with end dams at both ends. Evidence of the installation of end dams was not observed at this stepped flashing.

13 – Improperly installed flexible membrane thru-wall flashing at stepped foundation wall. No end dams are visible.

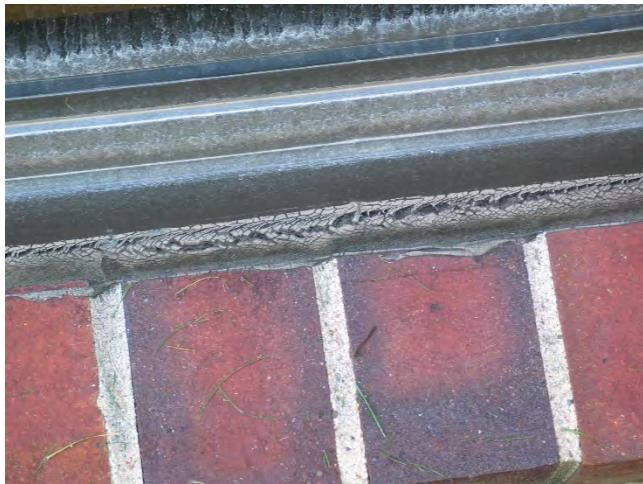
Sealant surrounding windows and doors was cracked and deteriorated (photo 14). In one location, it was observed that sealant had been installed just above the flashing at a window head, blocking the flow of water and trapping it within

14 - Cracked and deteriorated sealant around windows.

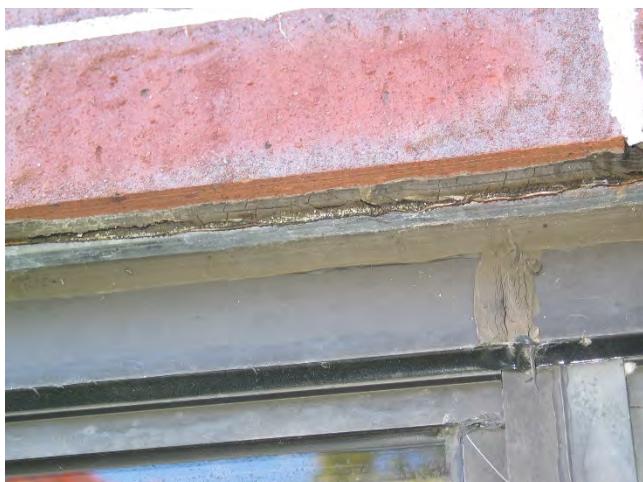
the window/wall assembly (photo 15). Control joints in the brick masonry were also cracked and deteriorated (photo 16).

15 - Sealant installed above flexible flashing at the head of a window preventing water from exiting from wall cavity.

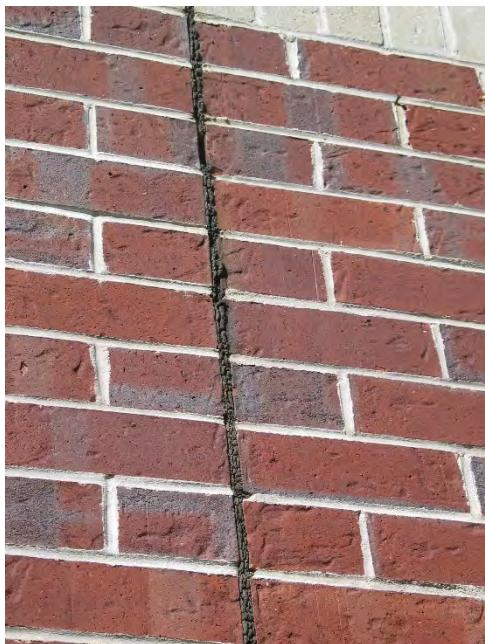
16 - Cracked and deteriorated sealant at masonry control joint.

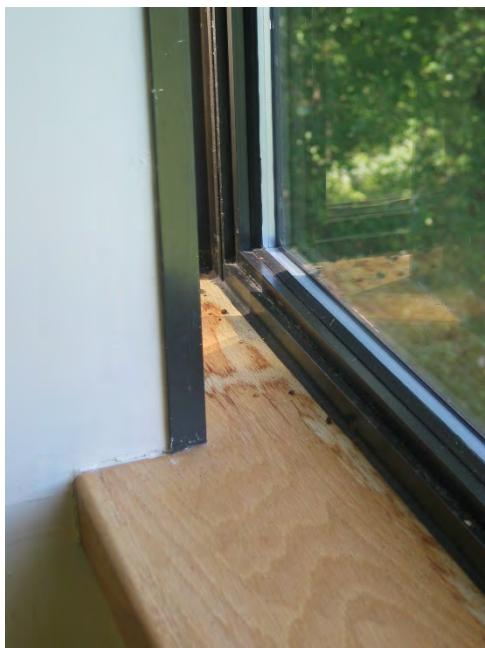
A history of water infiltration around windows was evident on the interior of the building at water-stained wood window sills observed on both the first and second floors throughout the building (visible both inside during tour of selected vacant tenant spaces and through windows in other spaces from the outside of the building) and stained and/or peeling paint observed in several locations (photos 17, 18, 19, 20).

17 - Water stained wood window sill at second floor window along north wall.

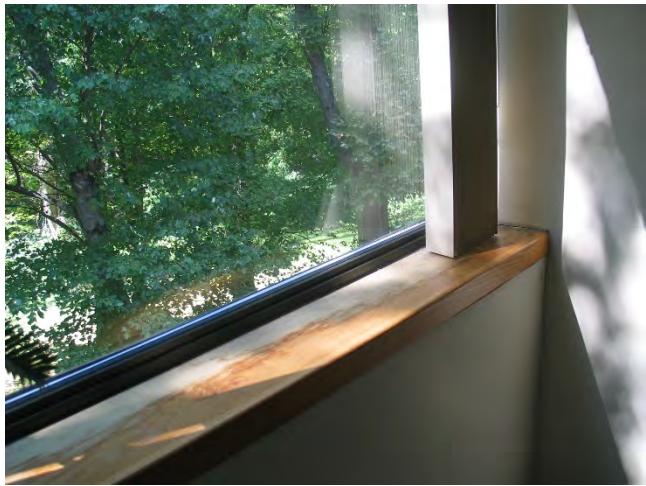
18 - Water stained wood window sill at first floor window along west wall.

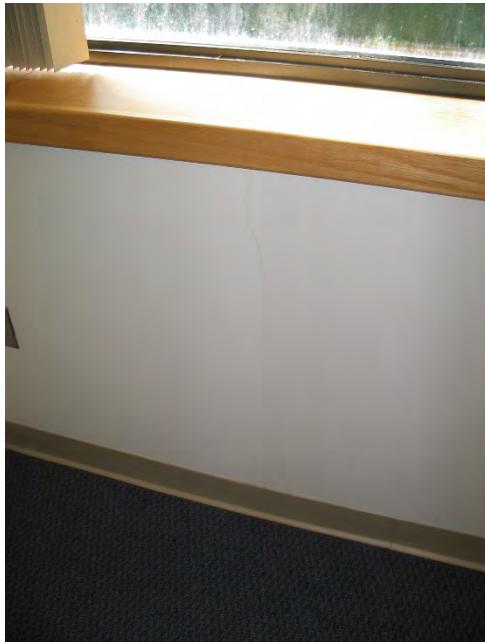
19 - Water stained drip running from under wood window sill down to wall base at second floor window along west wall.

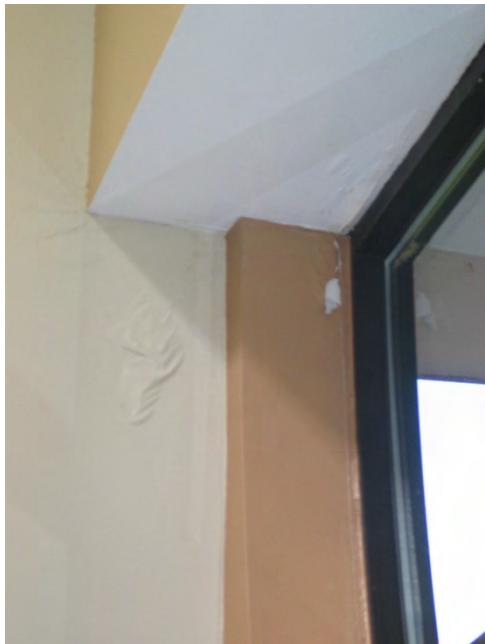
20 - Chipped and peeling paint from water intrusion at head of lobby storefront. Water penetration likely from storefront above at second floor level entrance canopy.

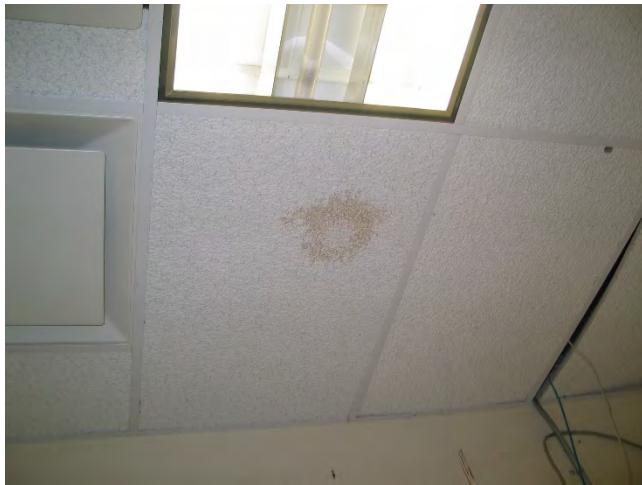
Ceiling Conditions: Good – ACT was generally in good condition with some water stained tiles observed on the second floor (photo 21). Some ACT tiles were chipped.

21 - Water stained ceiling tiles on the second floor.

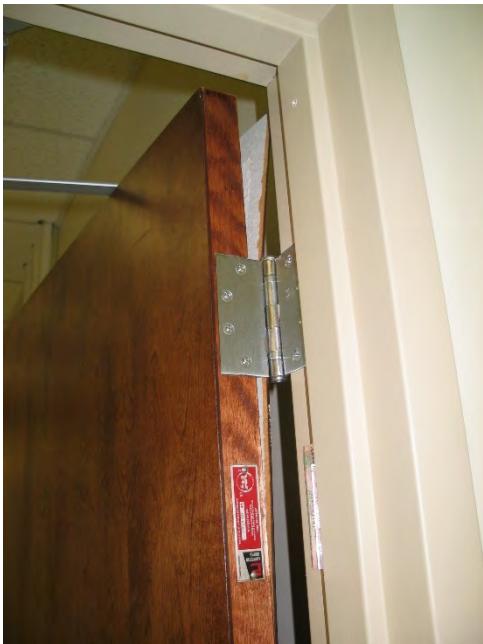
Door Conditions: Poor to good – Condition of doors varied widely. Observed deficiencies included chipped, peeling and delaminating wood veneer (photo 22). Some fire rating labels were observed on doors, but others were lacking on doors that should be fire rated.

22 - Delaminating wood veneer at wood door in second floor tenant space.

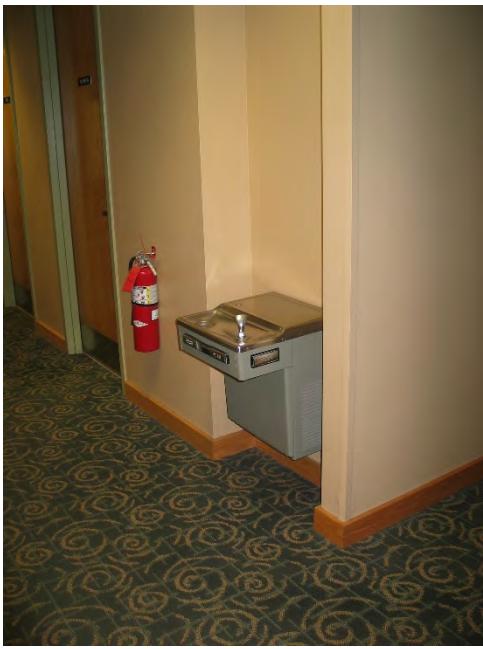
23 - Typical single level, non-ADA compliant drinking fountain outside toilet rooms.

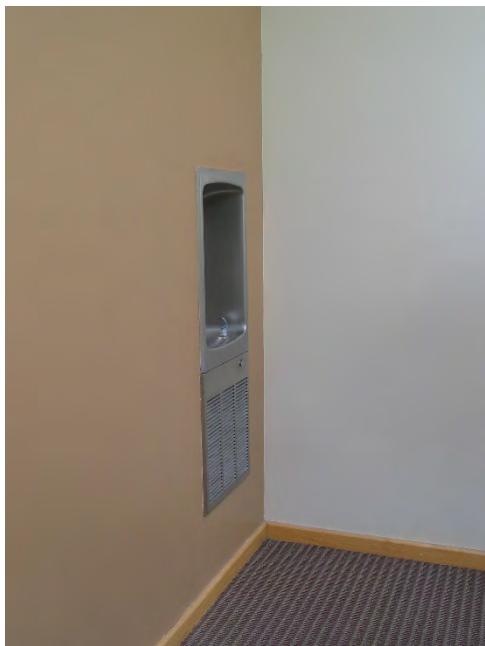
24 - Typical single level, non-ADA compliant drinking fountain in lobby.

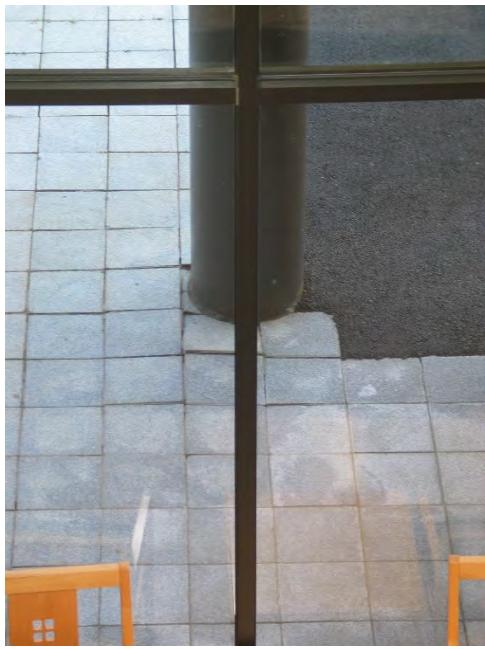
25 - Pavers at main entrance provide an uneven walking surface.

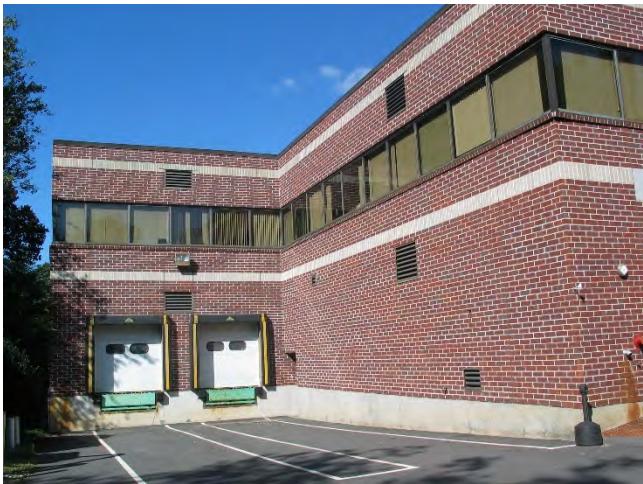
28 - *Opening at the first floor in the corner is location of door exiting from egress stair. Note the close proximity to the truck loading bay. A vehicle in this location could impede emergency egress.*
