Conditions Assessment and Preservation Plan for
the

LEVI WETHERBEE FARMHOUSE

**Conditions Assessment and Preservation Plan for the
LEVI WETHERBEE FARMHOUSE**

December 19, 2016

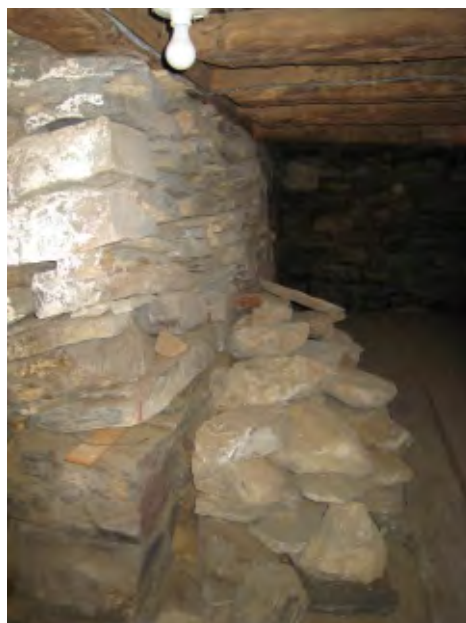
The foundation walls that support the chimney are severely compromised, particularly the west chimney wall, which has already partially collapsed. The stones from the collapsed section have been stacked at adjacent walls in an attempt to arrest further movement of these walls. While shoring of the first floor has been added at the northwest corner, little else has been done to the foundation walls to prevent further collapse. Additionally, the balance of the foundation walls is bowing inward, with fewer locations in good condition than not.

Photo 1: Failing foundation wall, east side of chimney (facing north, toward Middle Road)

Photo 1
Failing foundation wall, east side of chimney
(Facing north, toward Middle Road)

The entire foundation needs to be shored in order to preserve the upper levels. While there are several options available to mitigate or remedy the issues presented in Groton Engineering's 2014 report, these will either be trial-and-error approaches (such as water diversion) or severely impact the useable space of the basement (such as adding shotcrete along the interior face, which would also involve pouring a new slab and would rely on tying the new shotcrete into the first floor framing). The best solution is to temporarily shore the entire structure above the top of the foundations in a manner that would allow for an entirely new concrete foundation to be installed. The design of the new foundations should be cantilever retaining walls so that they are independently stable and do not rely on the first floor framing for lateral support.

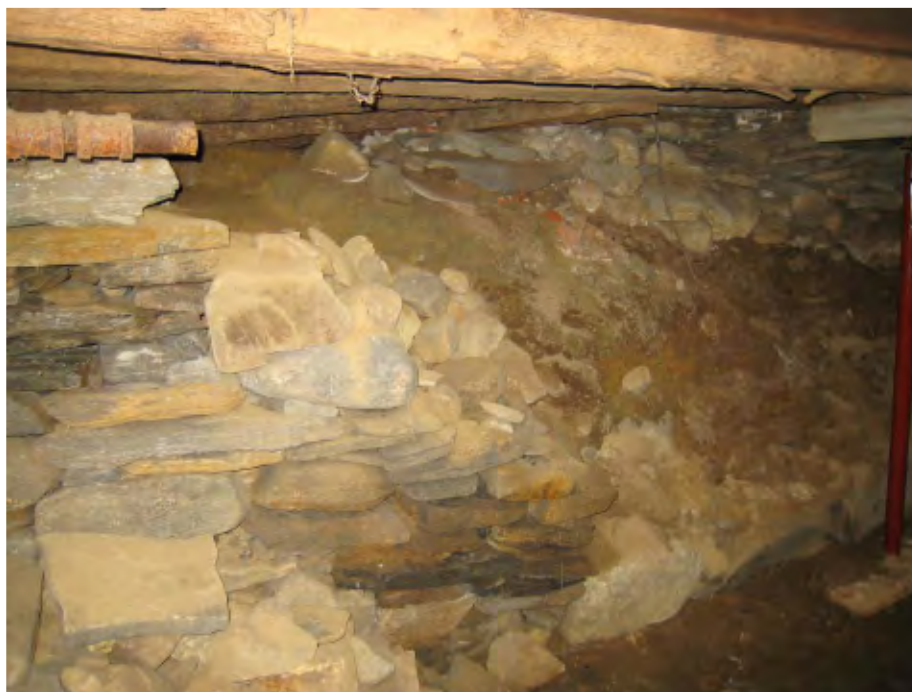
Photo 2: Failing foundation wall, west side of chimney (facing east, toward driveway/parking area)

Photo 2
Failing foundation wall, west side of chimney
(Facing east, toward driveway/parking area)

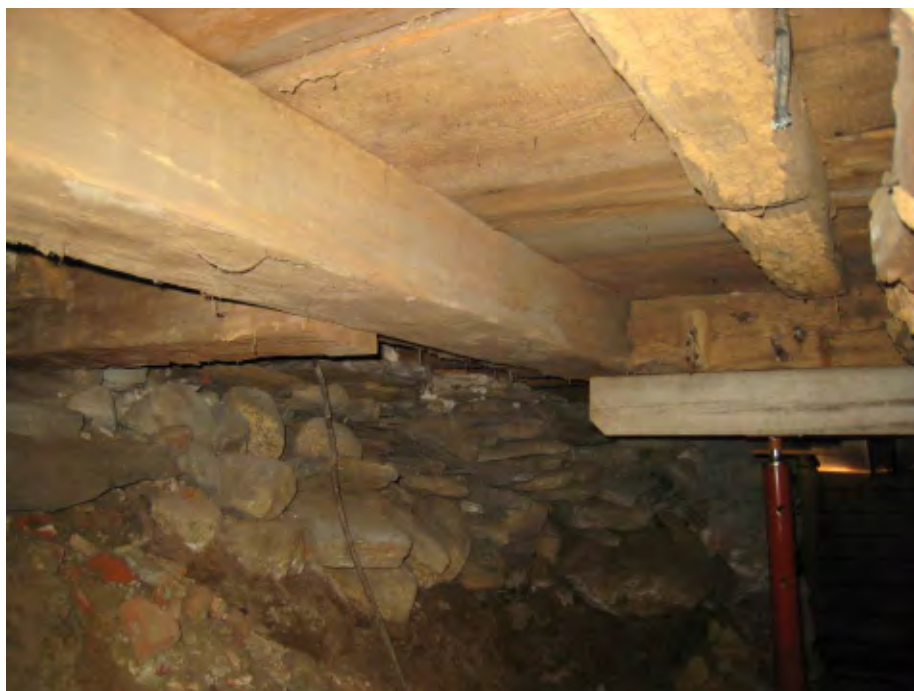
The first floor framing appears to be in relatively good condition at the southern two thirds of the footprint; however rear/north portion is rot- and insect-damaged. The damage at the east section appears to be minimal enough so that the floor is still stable, while the west section has been reinforced. The west-most joist has not been reinforced, and is not in contact with the subfloor. The damage at the center-north section is severe enough to have resulted in a collapse at the north end; while this space is generally inaccessible, it is likely that the sill is rotted at this location as well. The collapse of the west chimney wall has resulted in unsupported notched tenons of timber beam ends, which were likely previously receiving full-depth support from the collapsed walls. One of these has been restored by means of temporary shoring, while the other is not and appears to be splitting, which is common with this type of connection (see photos 3 & 4 on Page 2 of the Appendix).

Photo 3
Beam previously supported by now-collapsed chimney wall
(Facing south, toward barn)

As part of the restoration and repair, the north half of the first floor framing will require a combination of reinforcement and replacement, including sill replacement. Portions of this scope will need to precede the lifting/shoring of the structure to remain.

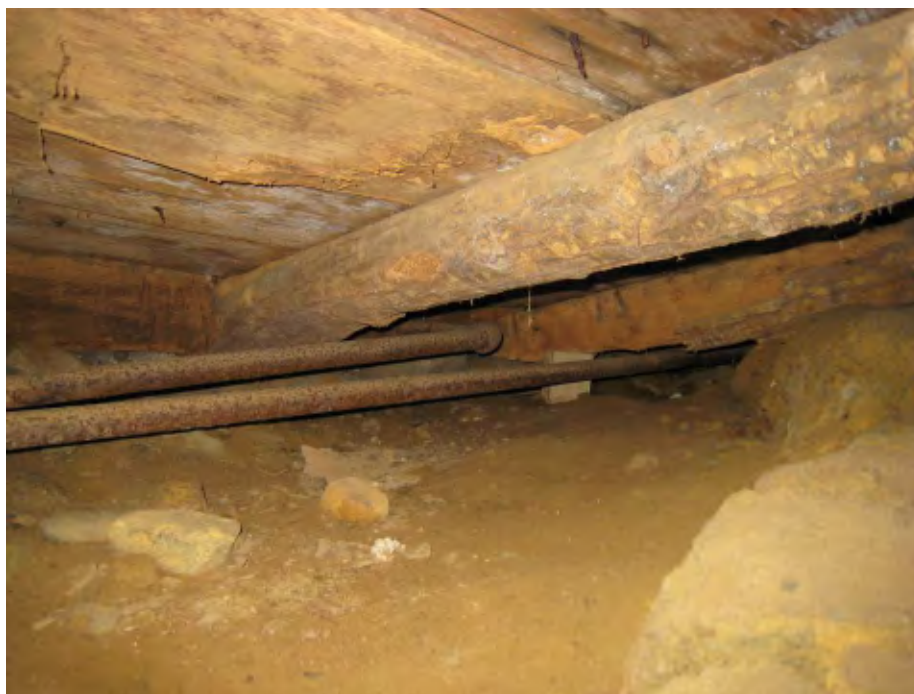
Photo 5: Collapsed first floor framing section (facing north/Middle Road, center section north of chimney as viewed from crawlspace)

Photo 5
Collapsed first floor framing section
(Facing north/Middle Road, center section north of chimney as viewed from crawlspace)

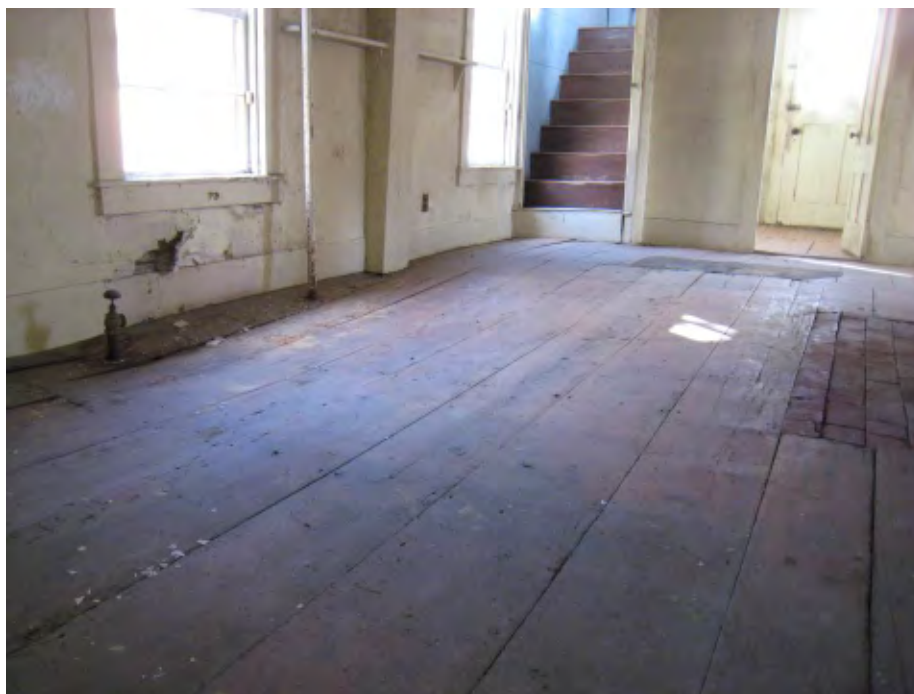
Photo 6: Collapsed first floor framing section (facing northeast/Middle Road, center section north of chimney as viewed from first floor)

Photo 6
Collapsed first floor framing section
(Facing northeast/Middle Road, center section north of chimney as viewed from first floor)

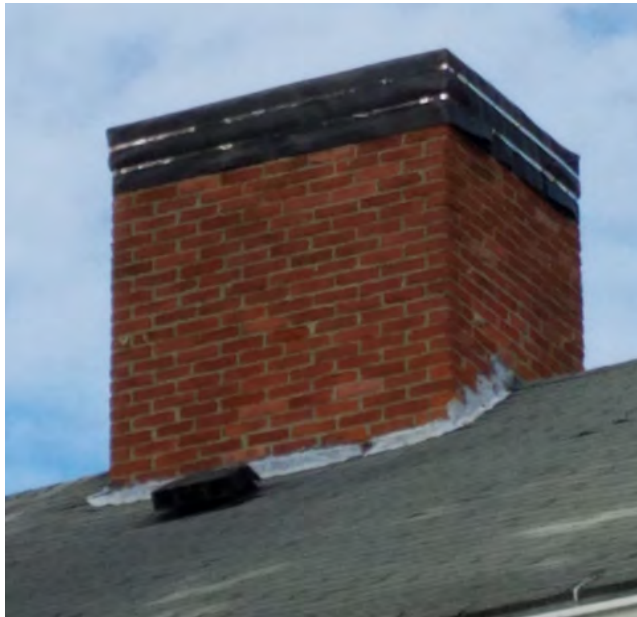
Chimney

- The exterior of the brick masonry chimney was observed through binoculars from the ground and it appears to be in moderate condition. Based on an inscription in the attic, there was work done on the chimney in 1990. Above the roof there appears to be some brick spalling on the east side. The pointing does not appear to be deteriorated.
- Step flashings are not interleaved with shingles, allowing water to get under the horizontal portion of the flashing.

- Replace spalling brick s on the east side.
- Inspect and repoint where necessary.
- When re-roofing, replace step flashings interleaving with shingles, replace the downslope apron flashing extending it 6 inches over the roofing and hemming it for stiffness.
- Replace the EPDM membrane covering over the top of the chimney with a chimney cap or other permanent measure to keep water out.

- The parging at the attic level should be removed so that the brick masonry can be fully assessed, and repaired as needed. See Structural Inspection report.

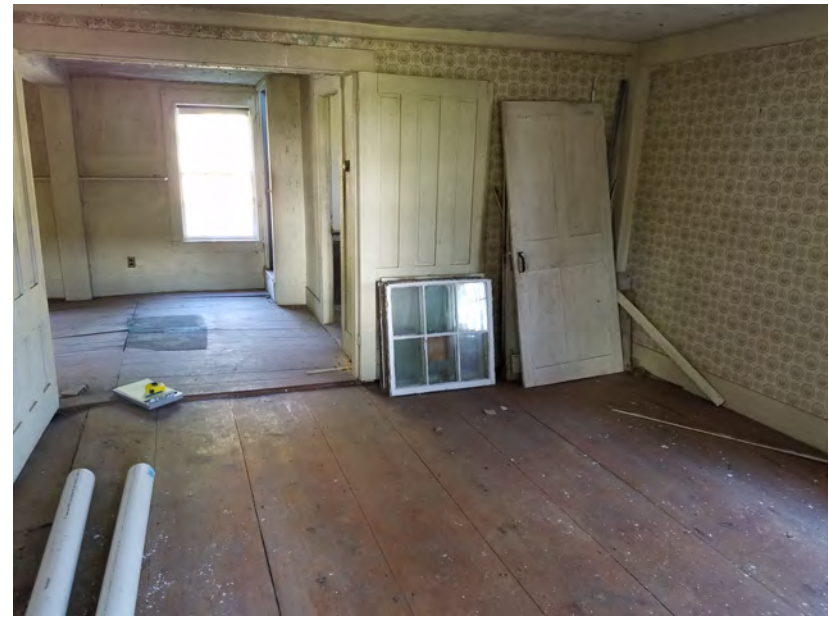
Historical sash stored in the house

- Repair historical sash that are stored in the house (approximately 12). Strip paint, remove loose glazing putty, and glass that is not well secured. Inspect corner joints and reinforce with hardwood dowels with resorcinol glue. Re-glaze where necessary. Remove modern replacement sash and reinstall refurbished historical sash.
- Scrape and paint all frame and exterior casings.
- Install window head flashings at window heads except where they exist (south side and east side of floor 1, the kitchen window, and west side of floor 2).
- Replace door casings at the south door (101)
- Remove screen door stops on the jambs at south door (101).
- Replace exterior casings, sill, and apron at east door (106) and install head flashing.

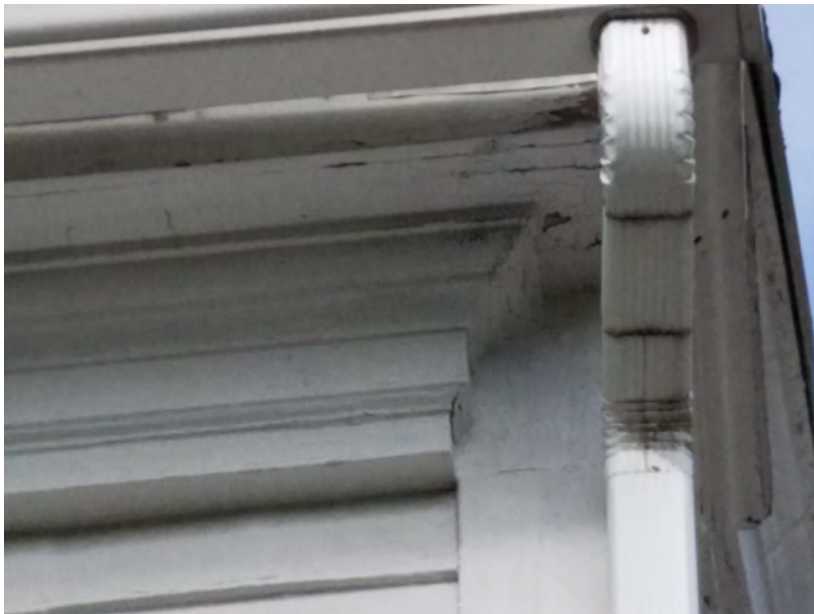
- There is a wood crown molding and fascia board along the eave and rakes. Along the eaves the molding and fascia form a boxed cornice with a soffit. The cornices return around the corners at the gable ends. There are a number of squirrel holes, especially at the southeast corner. The molding and fascia is decayed in some spots, especially behind gutters. It is not clear through binoculars whether all the cornice returns are capped with flashings.
- There are modern aluminum gutters and downspouts on the north and south eaves. Based on the presence of the crown molding, it is not likely that the house originally had gutters, but they may be a necessity until the site drainage issues (see above) are remedied.

Condition at southeast cornice return. Note cornice below soffit.

- Replace cornice moldings and fascia at squirrel holes, especially at the southeast corner, and behind gutters where decayed. Inspect cornice returns close up and install flashings at the tops if missing.
- Ideally the modern aluminum gutters and downspouts on the north and south eaves should be removed as it is not likely that the house originally had gutters, but first the site drainage issues (see above) should be remedied. A 12-16" wide gravel strip should be installed in the ground below the north and south eaves.

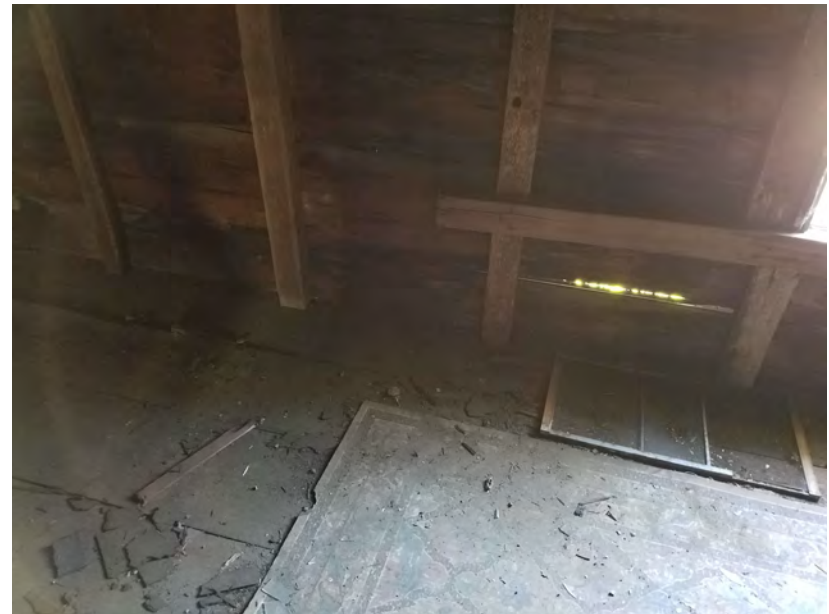
Gaps in the gable end siding and sheathing at the attic.

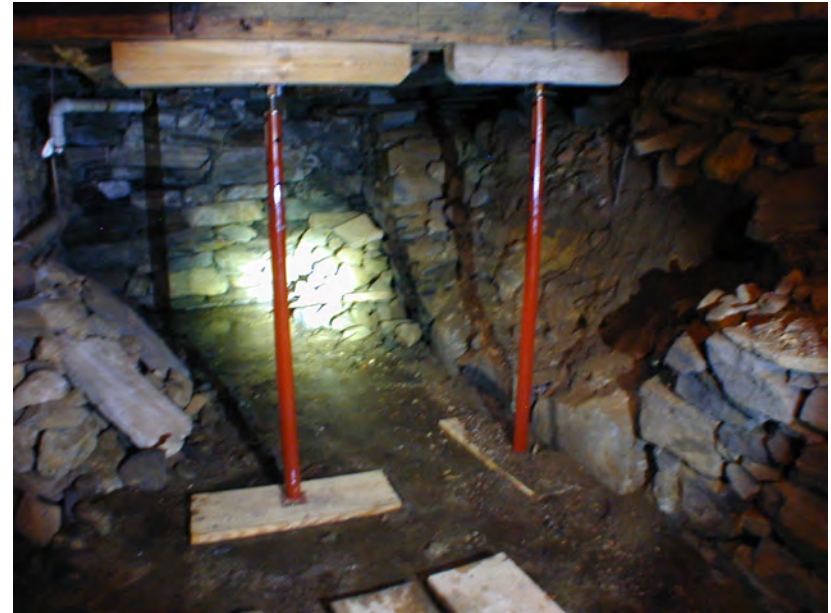
Failure of the stone foundation at the chimney.

- Temporarily shore the entire structure above the top of the foundations in a manner that would allow for an entirely new concrete retaining wall foundation to be installed. See Structural Inspection report.
- Alternate: Apply Shotcrete to the inside of the foundation wall. This method is not recommended.

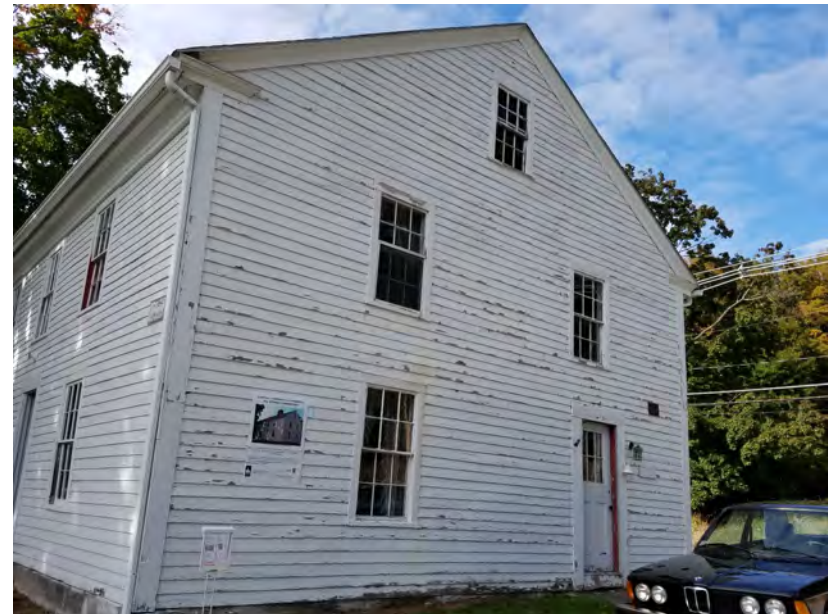
- A priority would be repainting the exterior, which is showing signs of peeling and paint deterioration which will allow siding and trim to get wet and decay.

Typical condition of paint. East side shown.

- Hand scrape off paint that is not tenaciously adhered to the substrate, hand sand ALL surfaces, feathering edges of remaining adhered paint. Assume existing paint contains lead. Take suitable precautions required by law to protect workers and prevent spread of paint dust to adjacent properties. Follow recommendations of National Park Service Preservation Brief #10 -Exterior Paint Problems on Historic Woodwork.

- Paint with one coat oil based primer and two coats acrylic alkyd house and trim paint
- Replace siding boards show splitting with pine clapboards to match (±1% on the north side, ±2-3% on the west side, ±5-7% on the south side, ±2% on the east side. Fill holes on the south side.
