# Steele Farm Management Plan

*Historical and Ecological Solutions  
for a New England Farmscape*

Boxborough, Massachusetts

Jennie Bergeron | Ben Fairbank  
The Conway School  
Spring 2015

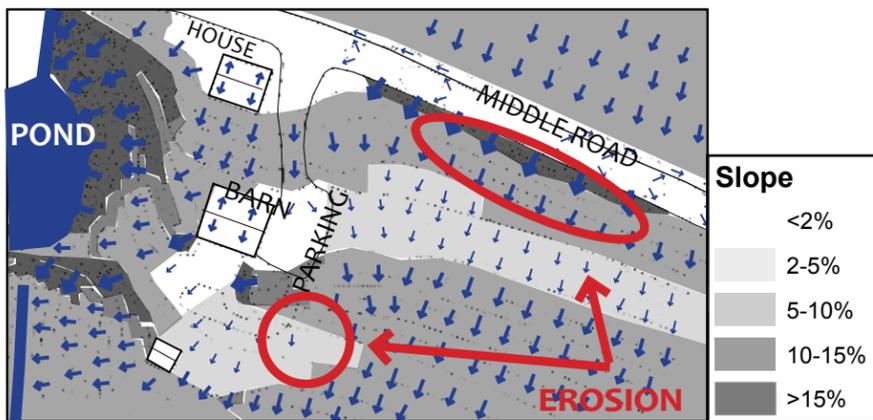
**ENTRANCE AREA:** There are slopes greater than 25% around the man-made fire pond and perennial stream, and immediately adjacent to the road, north of the field. With a high frequency of human activity occurring directly around these slopes, natural resources are subject to possible contamination and/or erosion. Erosion is now occurring next to the road and parking.

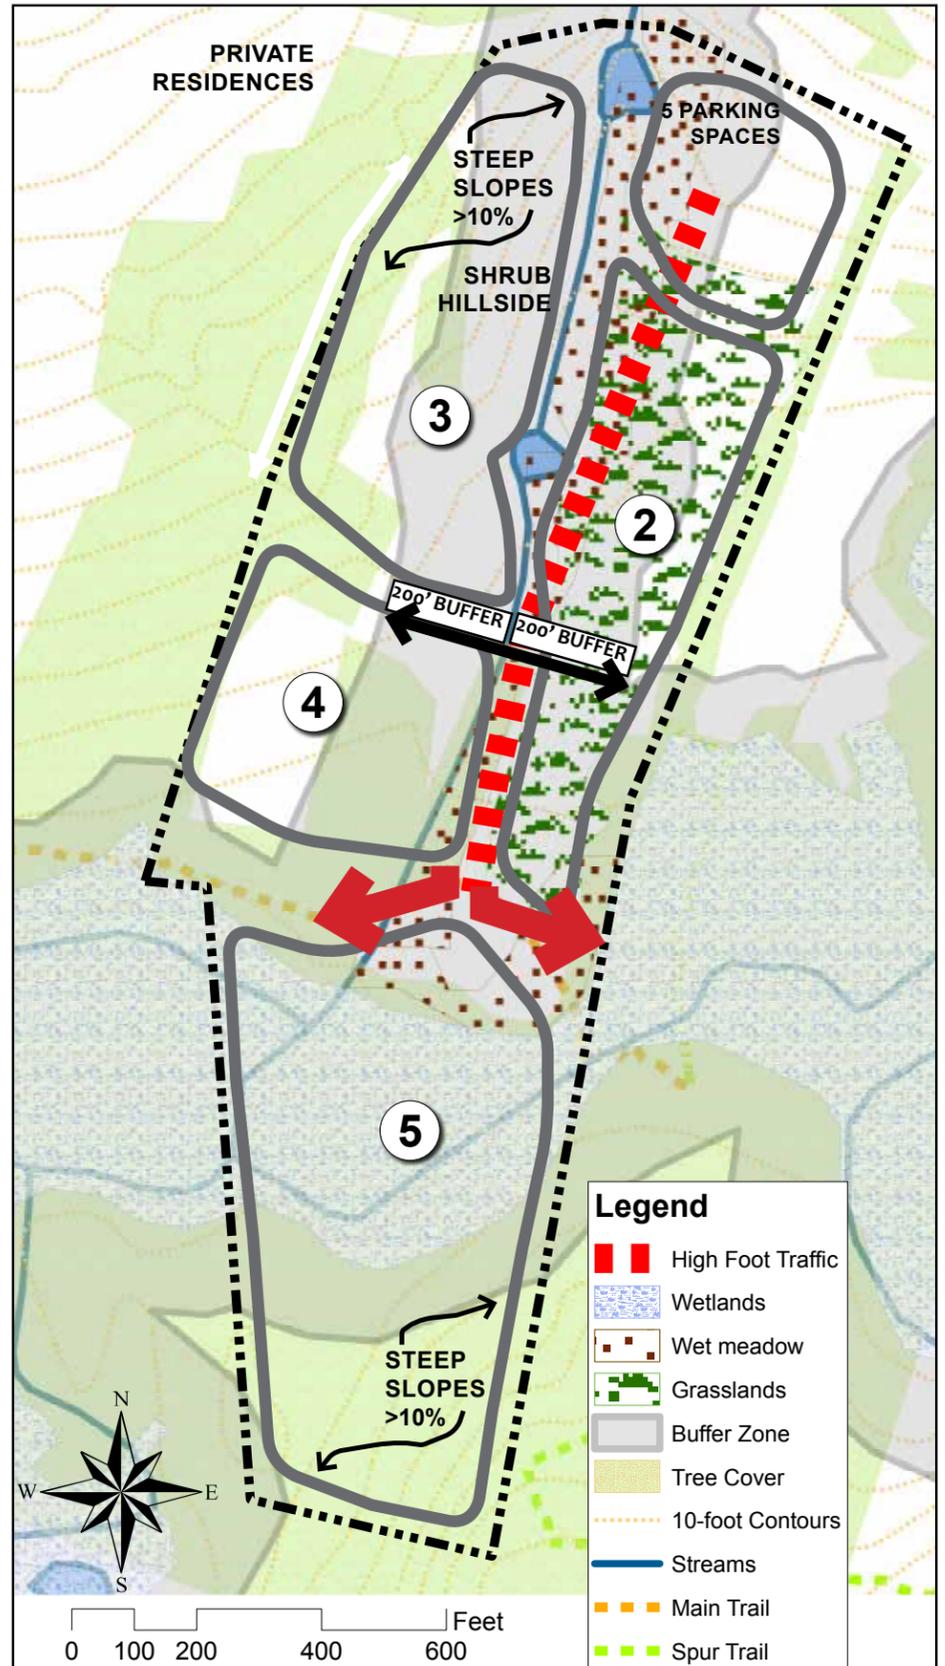
Steele Farm is shown here broken down into five zones based on site conditions. Foot traffic is the highest in Zones 1 and 2 where fragile grassland and wetland habitat needs protection. Visitors are diverted to east and west away from the red maple swamp and white pine forest, where there are opportunities for more recreation. Steep slopes surround a perennial stream at the entrance and shrub hillside to the west where parking, hiking, dog-walking, and horse-back riding might impact wetland resources. A secluded meadow to the south has relatively flat terrain and is largely outside of the 200-foot buffer of the stream, but it has trails that are not clearly marked.

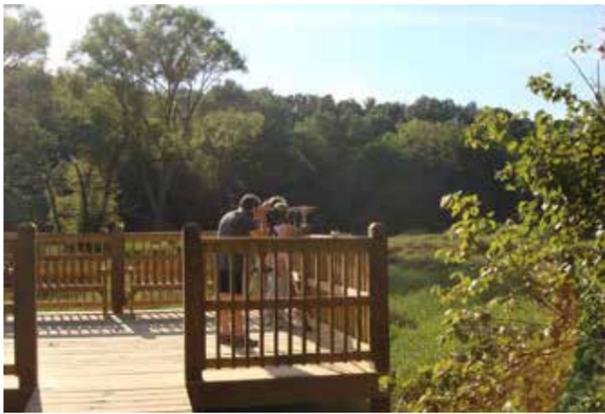
Grassland observation platform.

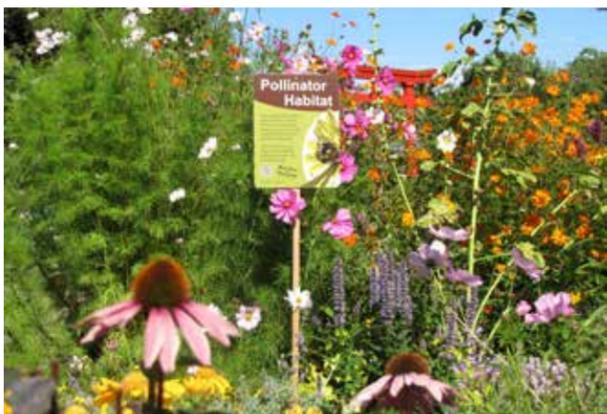
Pollinator/water infiltration gardens.

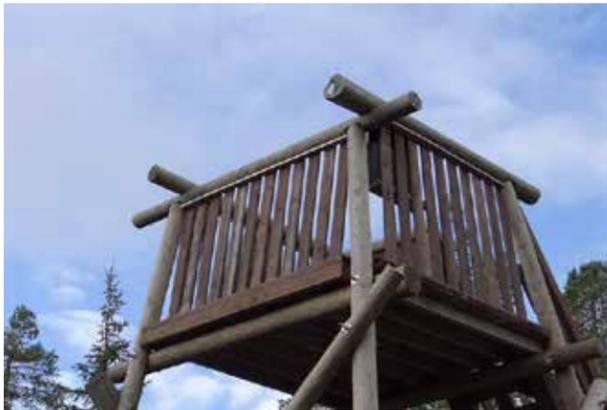
A high bird viewing platform.

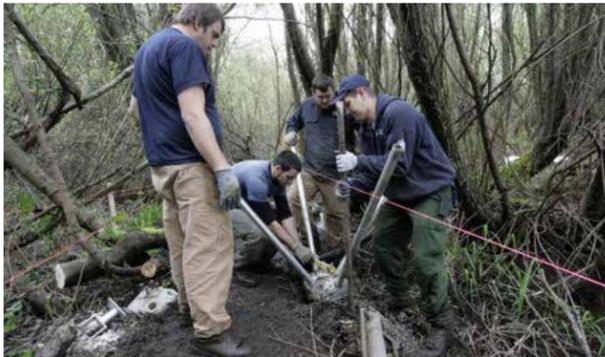
Diamond Piers being installed with no heavy equipment.

⑬ A diamond pier boardwalk connects the wet meadow and the wetland to a classroom platform for viewing plants and wildlife. This can be installed by community volunteers and requires no heavy equipment.

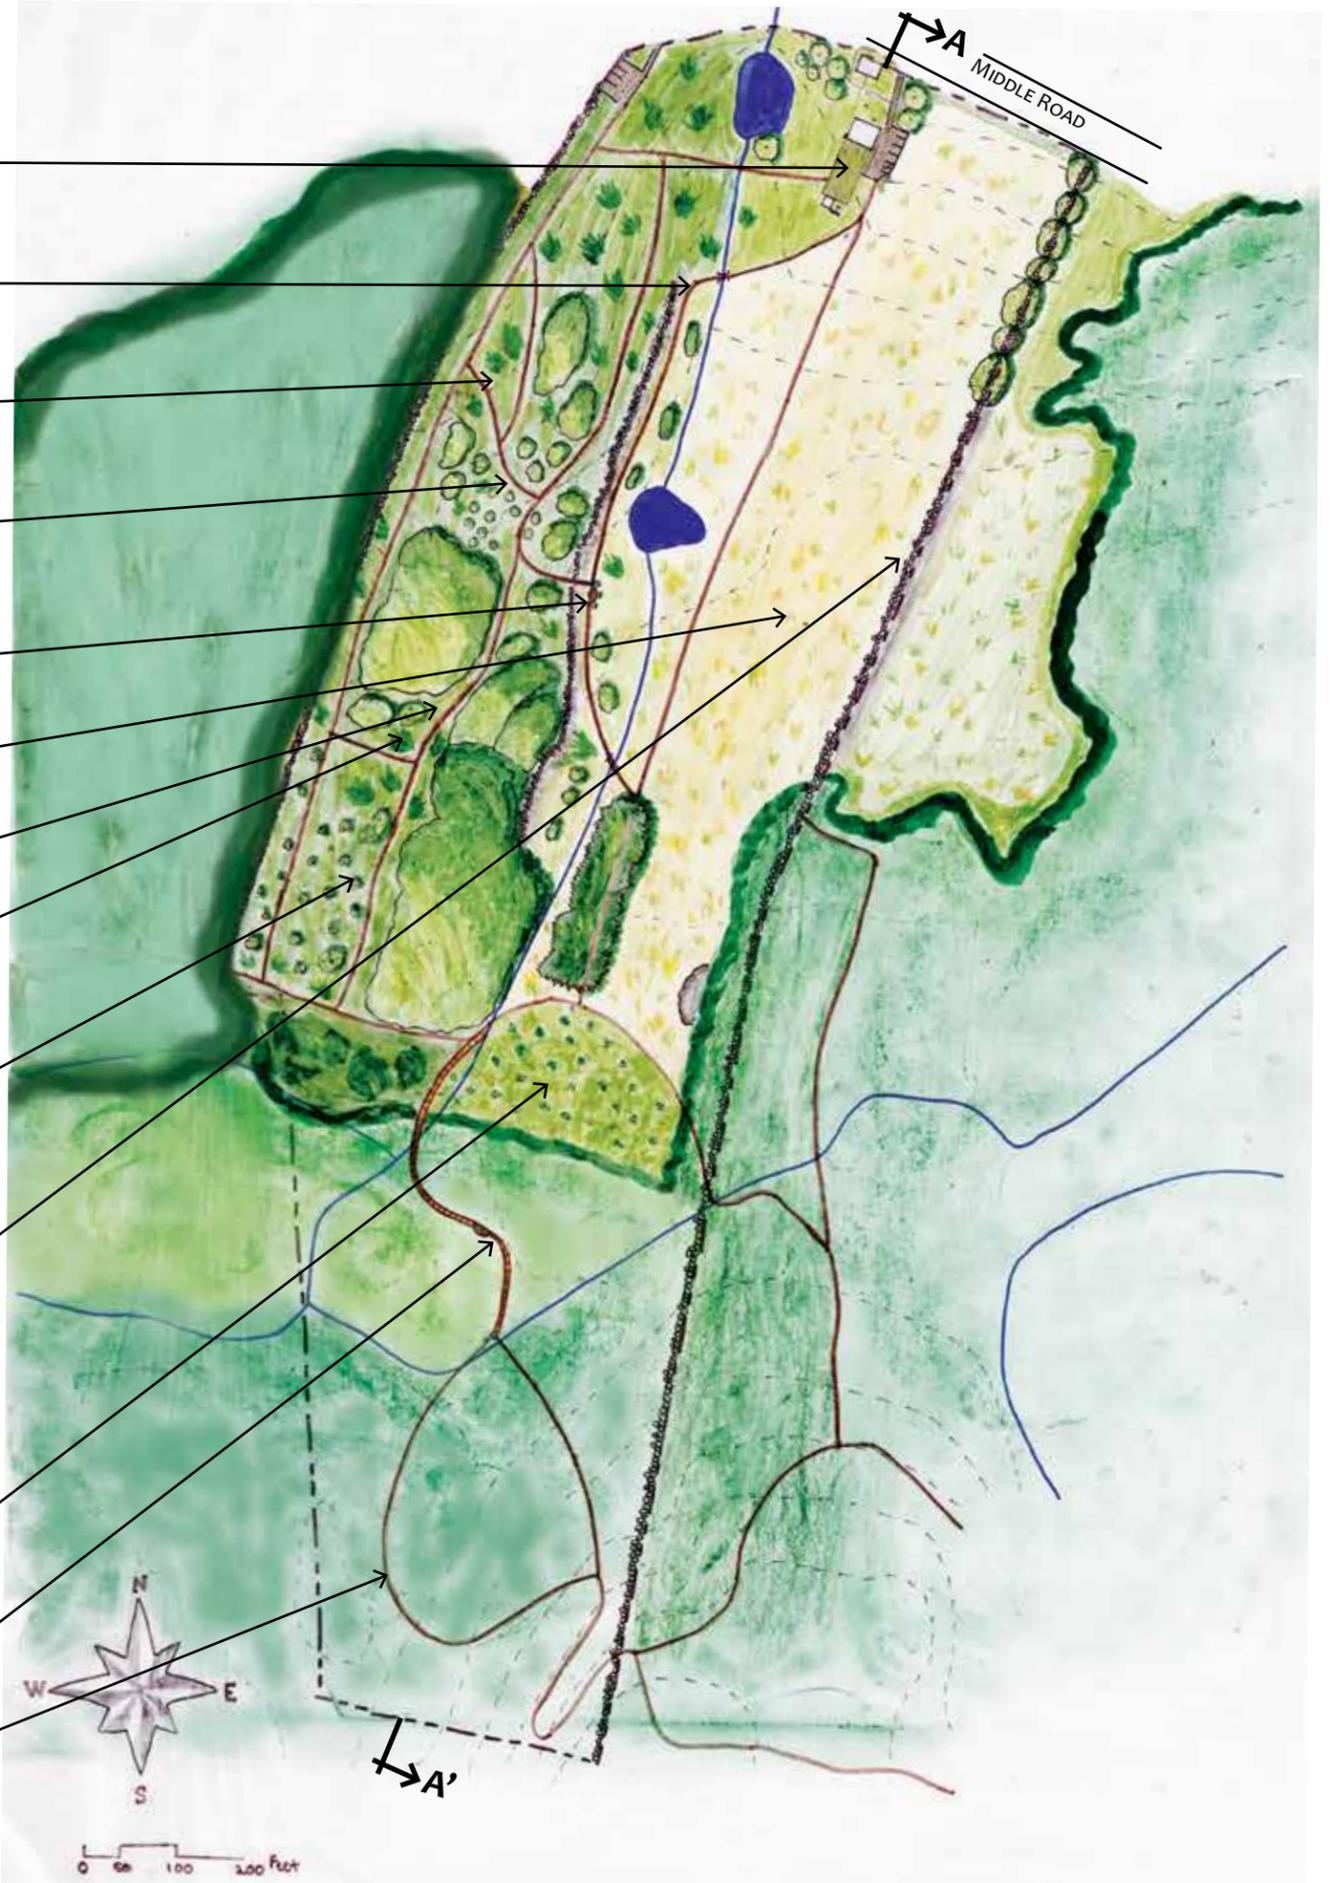
# Proposed Management Design Details

**Driveway & Parking Lot:** A gravel driveway with a 3" crown and 6" deep swales sends runoff away from the drive and parking lot. Asphalt will have to be removed, the surface regraded, and the new driveway maintained over time. To the east, an infiltration basin absorbs stormwater before it runs into the parking lot. To the west, water is sent to a tunnel along the edge of the parking lot before it runs off into more swales to the western side of the trail.

**Street-side Erosion Control:** An infiltration swale captures runoff coming from Middle Road on >25% slopes. Invasives are removed, erosion control blankets are installed, and native deep-rooting grass seed is broadcast.

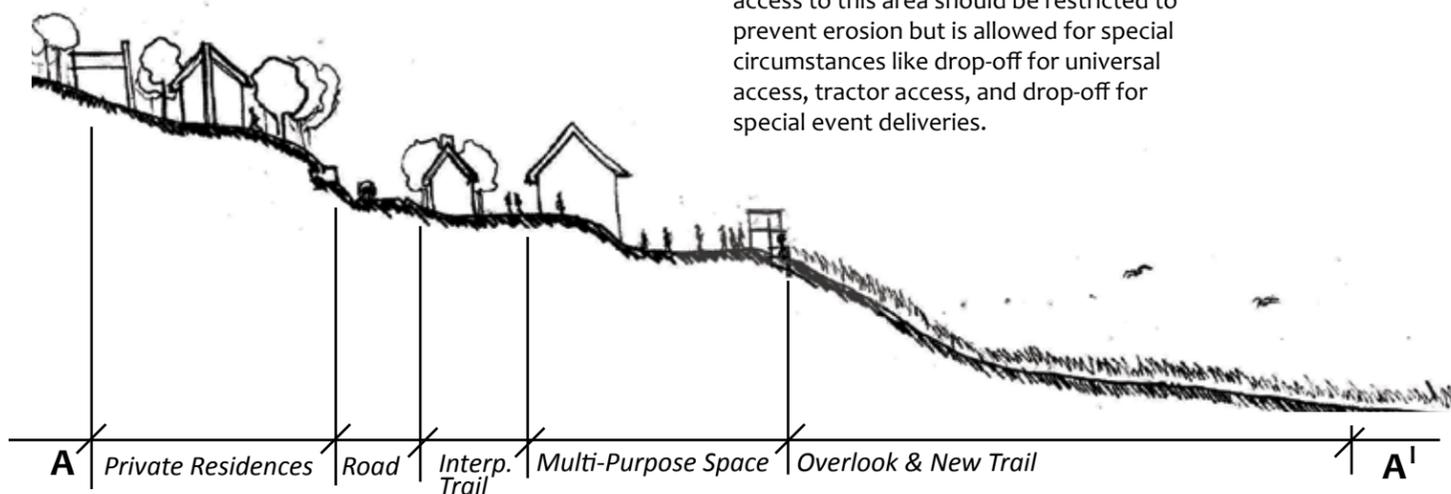
Conceptual Section Diagram - Not to Scale

**Regraded Trail Entrance:** The hillside south of the parking lot is filled to create a 10% slope with 6"-deep swales and a 3" crown to control the erosion. A more gradual slope eases access to the multi-purpose space and controls erosion in the long run.

This re-grading requires the least amount of cut but will require extensive fill to the east of the trail. This alternative works with existing drainage patterns and makes the trail more pedestrian friendly and easy to maintain.

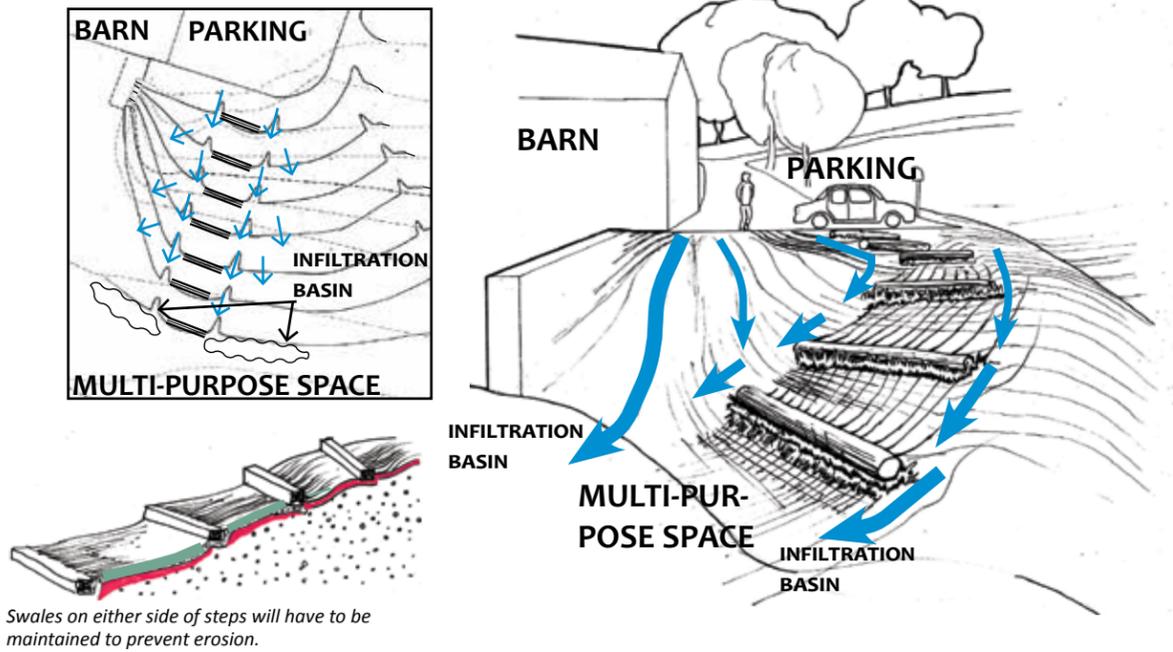
This re-grading requires some cutting along the west of the trail and will require extensive fill to the east. A gentler slope eases access and slows drainage, ensuring that the water bars will perform well and last long.

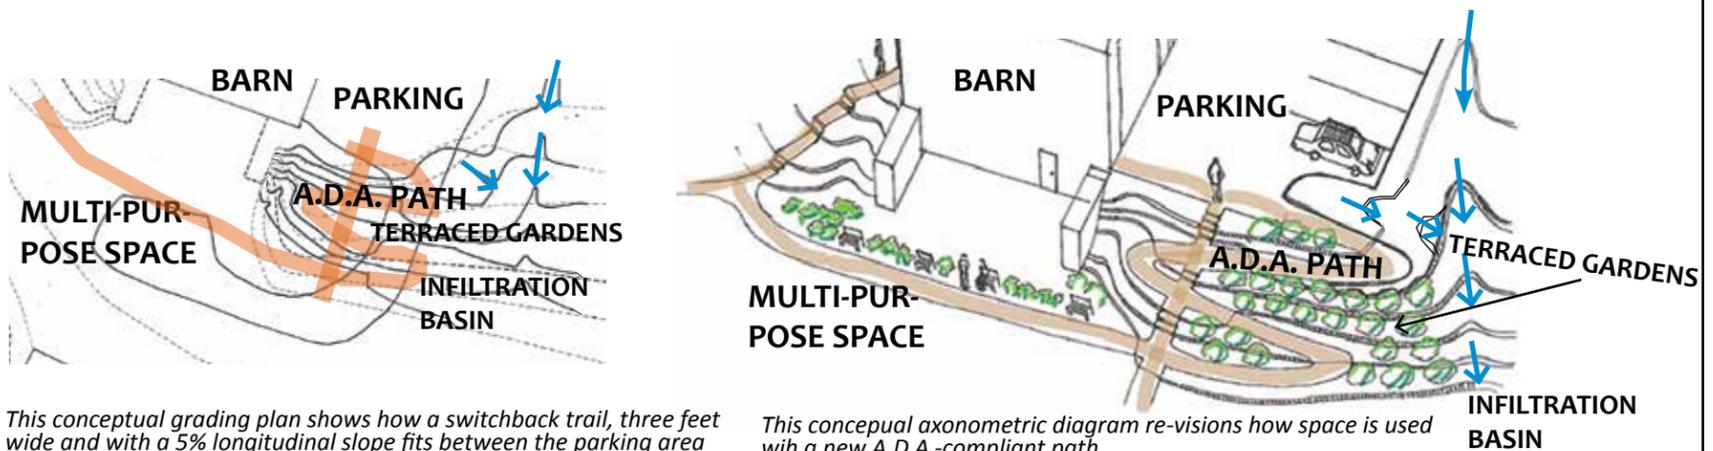
This conceptual grading plan shows how a switchback trail, three feet wide and with a 5% longitudinal slope fits between the parking area and multi-purpose space. This complies with A.D.A. regulations.

Universal accessibility is possible for this space. The conceptual axonometric diagram (below right) displays a barrier free switchback trail at a slope of 5% or less. Another more direct path with steps intersects this switchback trail at intermittent landings, outsloped at no more than 2%. In between the trails, 1-foot-deep retaining walls retain the moisture and erosion at every contour and provide an opportunity for terraced gardens to beautify the area. Water is channeled via a swale to an infiltration basin to the southeast. With the right site engineering, this trail can be visually appealing while also providing A.D.A. access and erosion control.

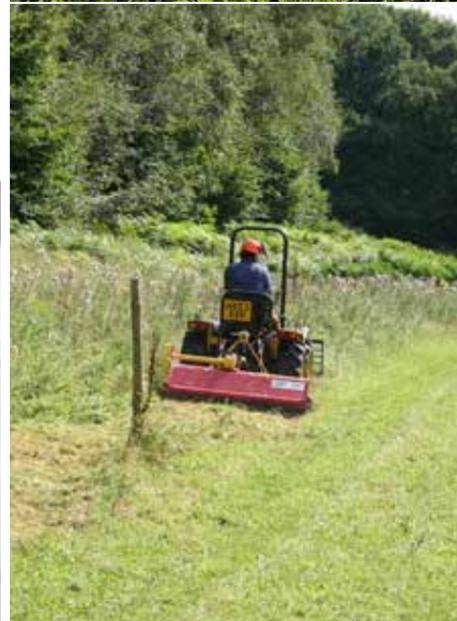
Mow grassland only once a year.

- During non-burn years, mow the **grassland once a year in mid-August or later**. It is imperative for grassland habitat health that this regime be followed, as the previously recommended date of July is too early for the needs of ground nesting birds.

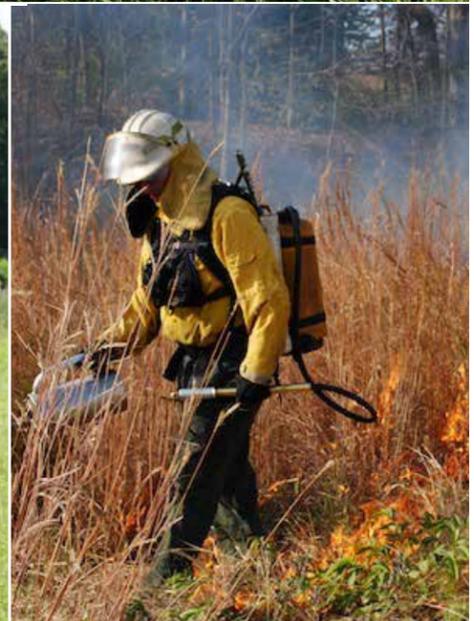
A burn boss makes a controlled grassland burn.

- Switchgrass, big bluestem, little bluestem, Indiangrass, broom sedge, sideoats gramma, and Eastern gamma are native species.
- **Controlled burning of the grassland every 3 years** will spur renewed growth of forbs and other plants, decrease buildup of dead plant material, enrich and reset soil nutrients, and decrease invasive plants that currently pose a problem. A burn boss will need to be hired for controlled burn organization and management. They are readily available in Massachusetts. Visit: [http://www.tncfiremanual.org/Contracting\\_a\\_burn.pdf](http://www.tncfiremanual.org/Contracting_a_burn.pdf)

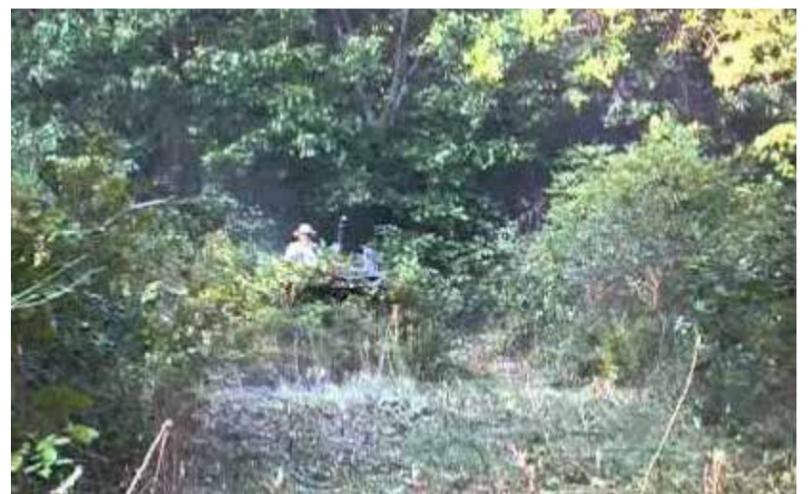
The hillslope should be selectively brush hogged every 3-5 years to maintain shrubs and trees and prevent forest secession.

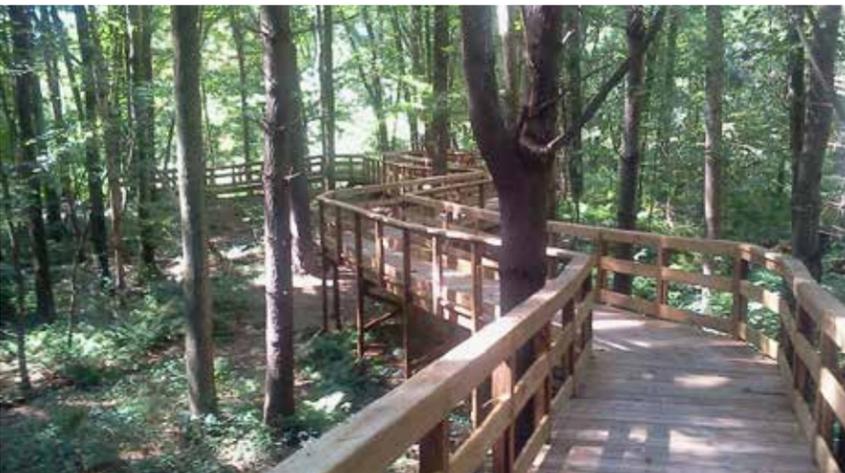
An extensive woodland boardwalk at the Silvio O. Conte wildlife area, Hadley MA, provides inspiration for Steele Farm's wetland boardwalk system.

- Boardwalk material can be milled from wood harvested from the white pine forest on-site. A more rot-resistant wood like cedar may be used and natural oils and resins can be applied to protect the wood from moisture.

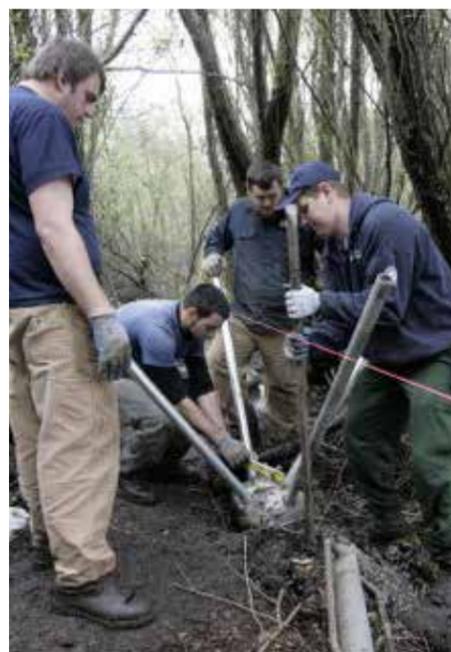
Diamond piers being installed by volunteers.
