# GROTON ENGINEERING, LLC

FOUNDATION ASSESSMENT  
for the  
1784 Levi Wetherbee Farmhouse  
484 Middle Road, Boxborough, MA 01719  
July 17, 2014

CLIENT: Town of Boxborough  
Town Hall, 29 Middle Rd.  
Boxborough, MA 01719

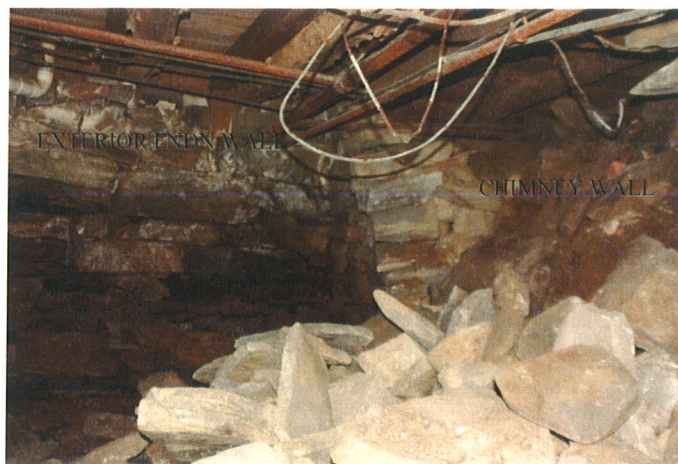
PHOTO #1 - Wall & Fallen Stone

PHOTO #1 shows a collapsed portion of the interior fieldstone wall that surrounds the central chimney's base. PHOTO #2 shows the stone laying on the sandy floor. The soil behind the fieldstone wall and under the chimney's base is a good gravel with a blend from fine sand to two and three inch stone. The fieldstone walls are all laid up dry, ie, no mortared joints. They are well built but depend on heat radiating from the basement to prevent frost buildup that can damage fieldstone walls.

When frost enters soil it causes any moisture therein to freeze and expand. That expansion pushes against the fieldstone that only has friction to resist sliding. When frost leaves in the warmer months, the water-soaked sand slips into the cavities created during the freezing/sliding action. Repetition over a period of years eventually forces stones to slide far enough that they fall out of a wall and cause others to go with them. That is what I believe has happened here. There is still soil behind the remaining wall and under the chimney but how compact and stable it is now, is not known.

Replace existing fieldstone foundations with 12" concrete ones that have 4" exterior shelves to carry a veneer of fieldstone. The 8" portion, exposed to the interior of the basement, can rise up to the first floor framing and be attached thereto. The wood floor joists, sills and other damaged framing can be replaced with like kind at greater expense or replaced with today's conventional lumber that meets code.

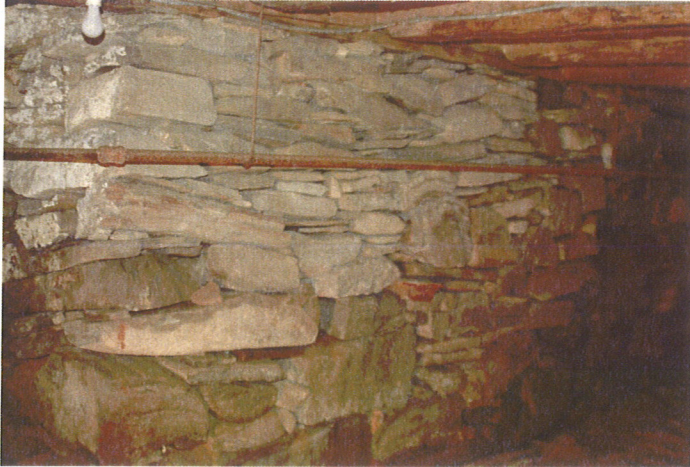
PHOTO #3 - Other Wall Supporting Chimney

The fieldstone retaining wall on the opposite side of the chimney is still in fairly good condition as can be seen in PHOTO #3. Also visible in this photo are the first floor joists of logs rather than sawn or hand hewn lumber. The beams to which the joists are connected, are hand hewn lumber. The wood framing is where it is supposed to be so this retaining wall is still doing its job. On the collapsed fieldstone wall the corresponding wood framing above has lost support.

The log floor joists are deteriorating from both rot and insect damage. I was able to push my sharp pointed jackknife about an inch into the wood in a number of places. So they have lost most of their original strength and will likely have to be replaced before the house can be re-occupied.
