**Town of Boxborough
Levi Wetherbee Farmhouse Stabilization
484 Middle Road
Boxborough, Massachusetts 01719**

**Schematic Design Submission
CBI Project No. 17159
December 1, 2017**

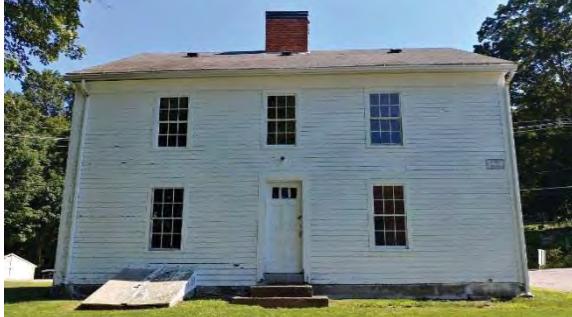
South elevation.
5

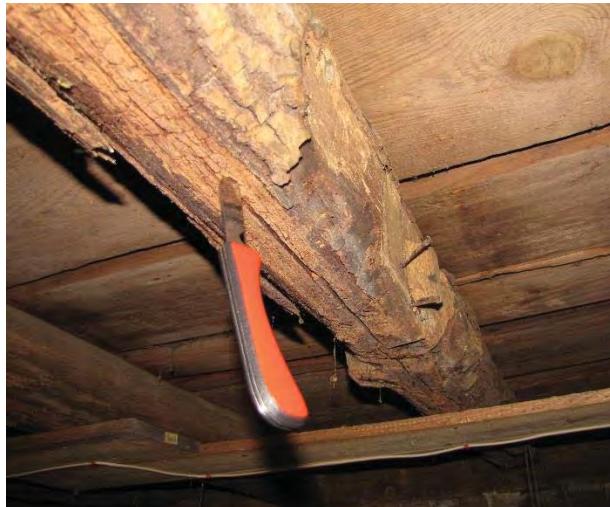
05

Photo similar to Photo 02.
06

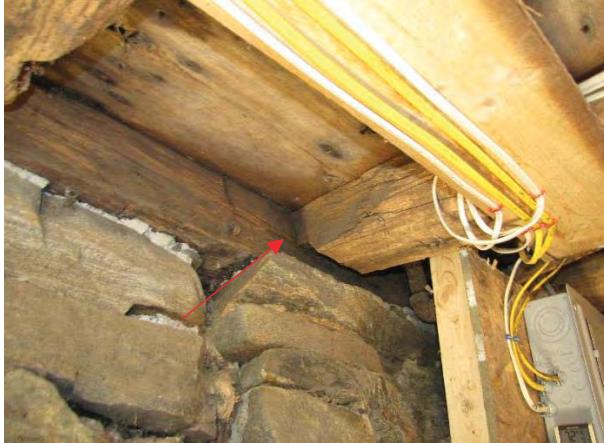
08

A photograph showing a close-up of a wooden log structure. A red arrow points to a specific joint where a log is tenoned into a wooden sill. Electrical wiring is visible in the background.	Photo of typical tenon joint at wood sill (red arrow).
09

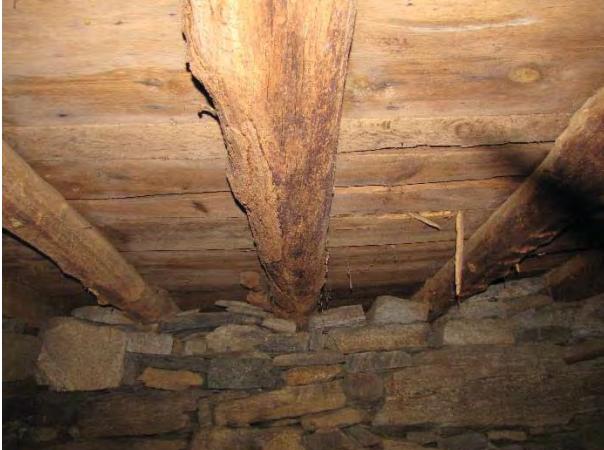
A photograph showing a view of wooden joists resting on a stone foundation wall. The wood is dark and appears to be in relatively good condition compared to the sill in the previous photo.	Photo of wood joists on stone foundation wall – northeast portion of foundation.
15

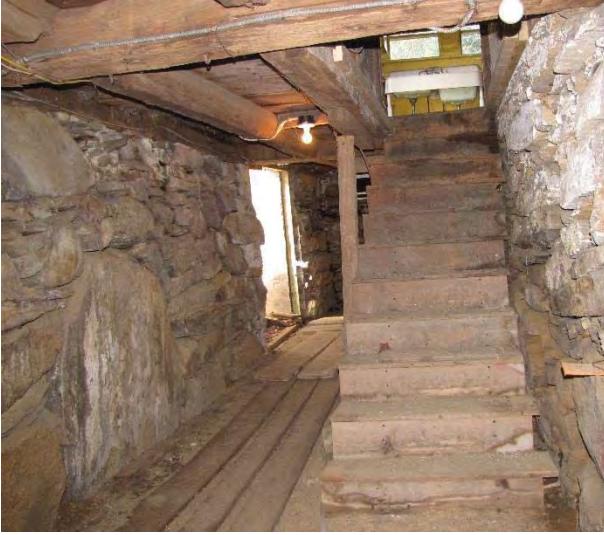
A photograph of a wooden staircase leading down into a cellar. The stairs are made of weathered wooden treads and risers. The walls of the cellar are made of large, rough-hewn stones. A small window is visible at the top of the stairs, letting in some light.	Photo of cellar stairs.

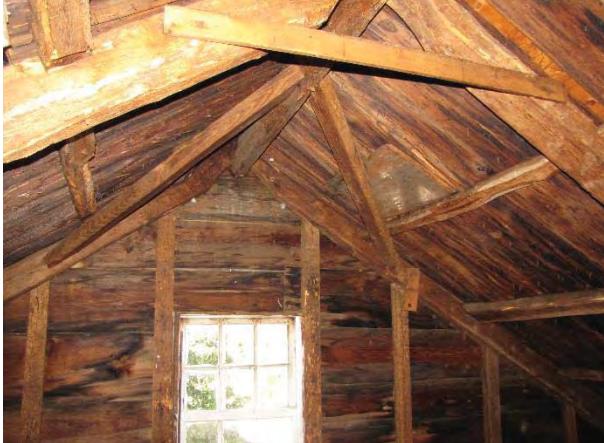
20

A photograph showing the interior of a wooden roof structure. The frame consists of numerous wooden beams, including rafters and wind girts. A small, multi-paned window is visible in the background, letting in some light.	Photo of roof framing – note roof rafters and wind girts.
21

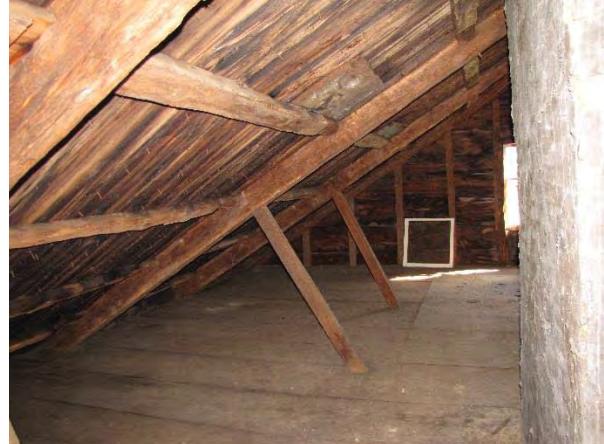
A photograph showing the interior of a wooden roof structure. The frame consists of numerous wooden beams, including rafters and wind girts. A small, multi-paned window is visible in the background, letting in some light.	Photo of roof framing.
22

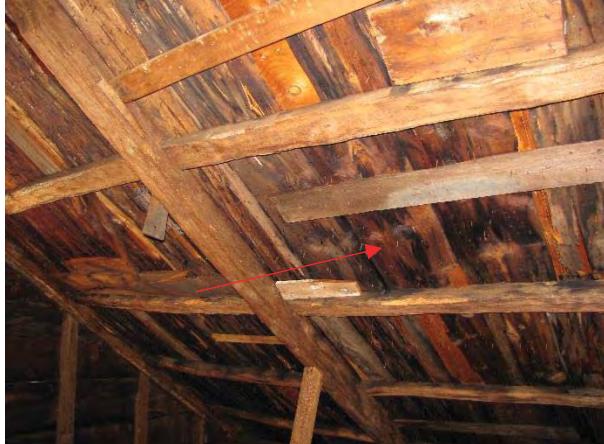
A photograph showing the interior of a wooden roof structure. The frame consists of numerous wooden beams, including rafters and wind girts. A red arrow points to a former opening in the original roof sheathing, which is now covered by new sheathing installed at an unknown prior date.	Photo of roof framing at former openings in original roof sheathing, now covered by new sheathing installed at an unknown prior date (red arrow).
