**National Register of Historic Places  
Registration Form**

historic name Levi Wetherbee Farm

other names/site number Wetherbee-Cobleigh-Steele Farm

street & number 484 Middle Road N/A not for publication

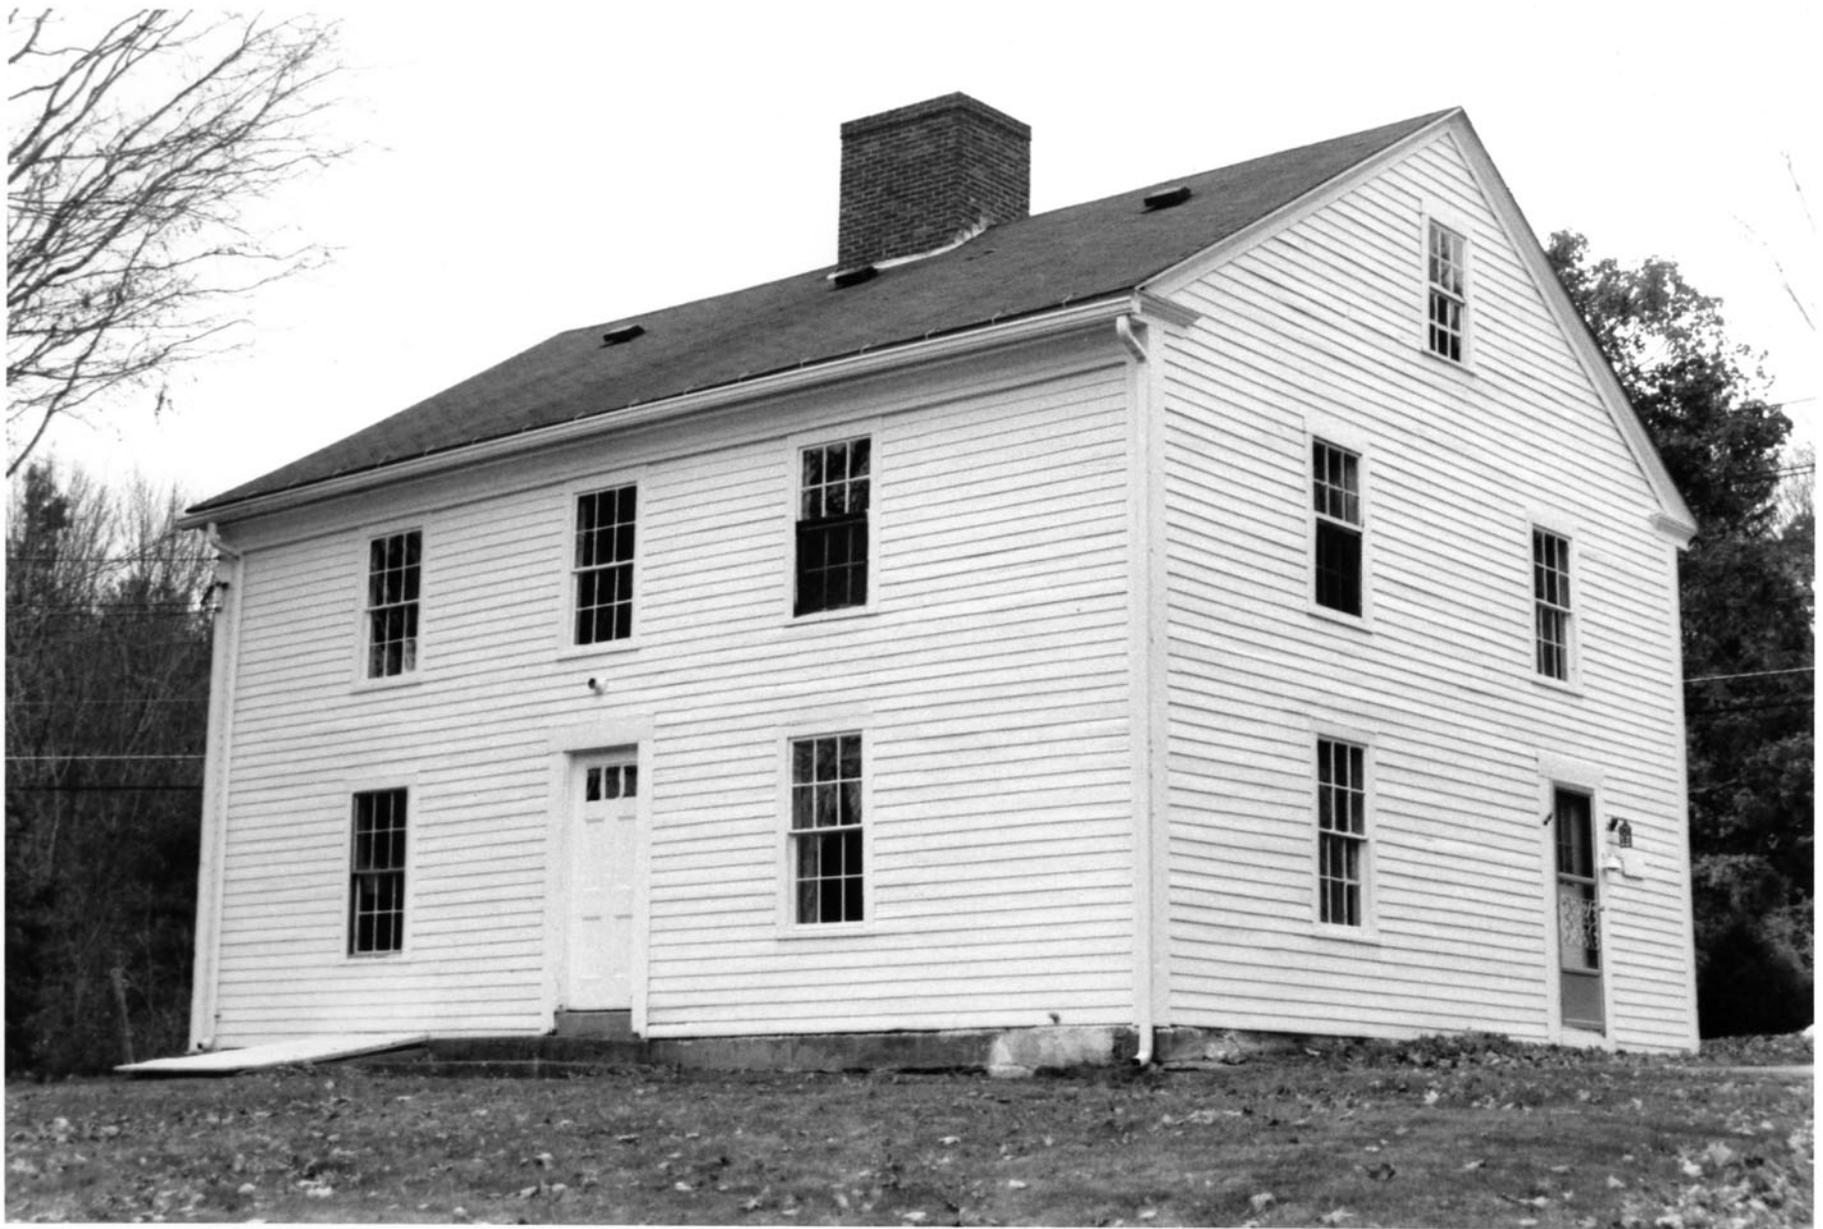
2. Levi Wetherbee House, mid-18th C/ca. 1800-1815: south façade and east elevation (Photographer: Anne Forbes, 2004)

**Levi Wetherbee House (Wetherbee Farmhouse)**, mid-18th C./enlarged ca. 1800-1815 (MHC.3;  
Map #1, Photos 1-5)

The farmhouse in its present form is a 34 x 28-foot south-facing, side-gabled, 3 x 2-bay, 2½-story, center-chimney house. Due to the relocation of Middle Road, the building stands with its back to the street. Clad in wood clapboard, with an asphalt-shingle roof, it rests on a fieldstone foundation topped with split granite blocks. Its south facade is symmetrically arranged. The center entry has a mid 19th-century door with what were apparently six recessed panels trimmed with applied moldings. The top two panels have been replaced with a line of three glass lights. The door surround consists of a simple enframing of wide, unadorned boards. Similarly, the windows have flat-board surrounds flush with the siding. The east and west gable-end elevations, which appear to have formerly had a symmetrical two-bay arrangement of openings aligned at first and second stories and a single 6/6 window in the gable peak, each have been slightly altered. The east wall has a wooden 20th-century, 6-light-over 2-panel door in the north portion, and the west gable end has two small mid 20th-century two-pane kitchen windows on the south part, rather than a single window. On the rear (north) wall, two 6/6's are aligned at each story, set somewhat off-center toward the east part of the wall.

Except for the two modern windows on the west gable end, all the windows are double-hung 6-over-6 sash. Some sash is of the mid 19<sup>th</sup> century type with narrow ogee muntins; others are later 6/6 replacements. The exterior trim includes a molded, boxed cornice with returns on the gable ends, and narrow cornerboards. Below the eaves on the north and south walls is a prominent bed molding above a narrow friezeboard adorned with a narrow architrave molding. A molding with a similar profile trims the lower edge of the crown along the eaves and at the gable ends of the roof.

The large brick center chimney rises through the roof ridge. Three small box ventilators on the south front roof slope are a minor alteration of the late 20<sup>th</sup> century.

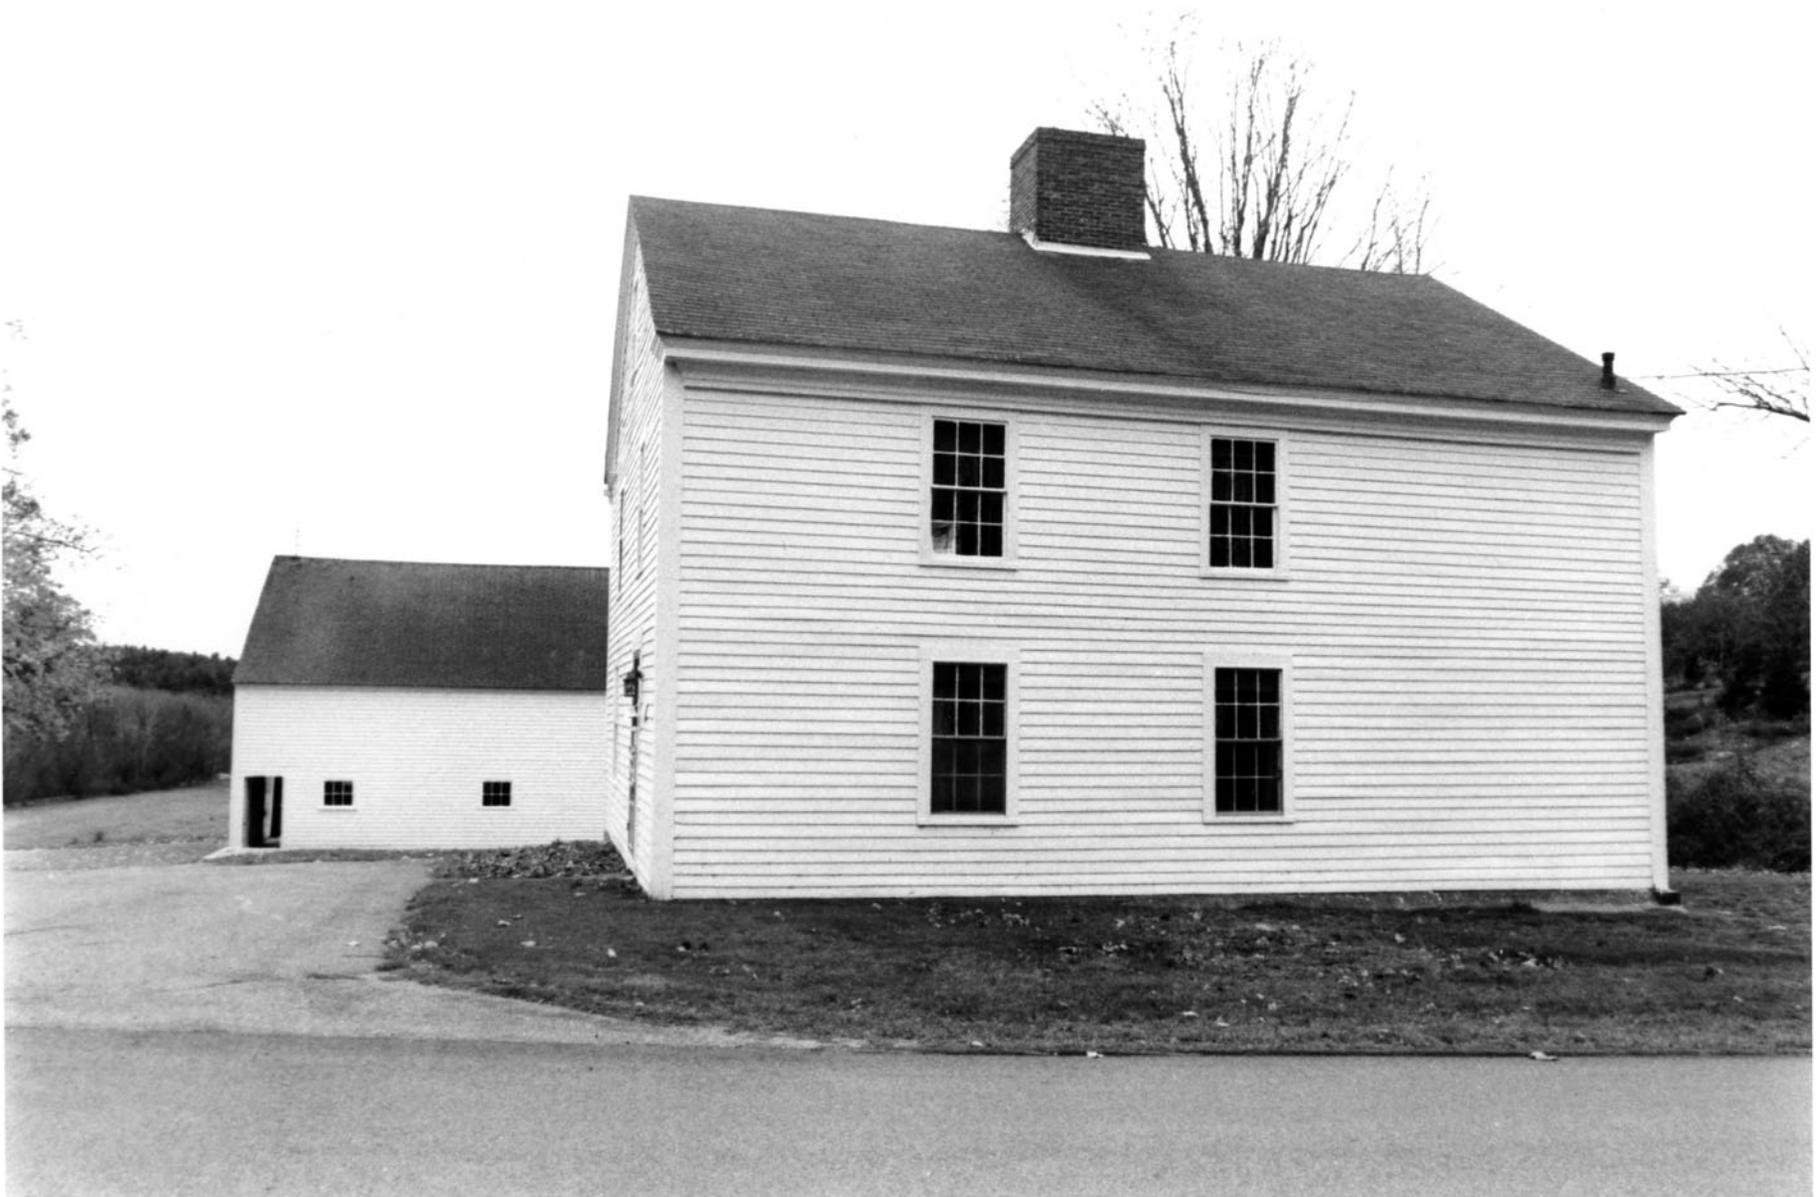
3. Levi Wetherbee House, mid-18th C./ca. 1800-1815: north elevation, with barn at rear (Photographer: Anne Forbes, 2004)

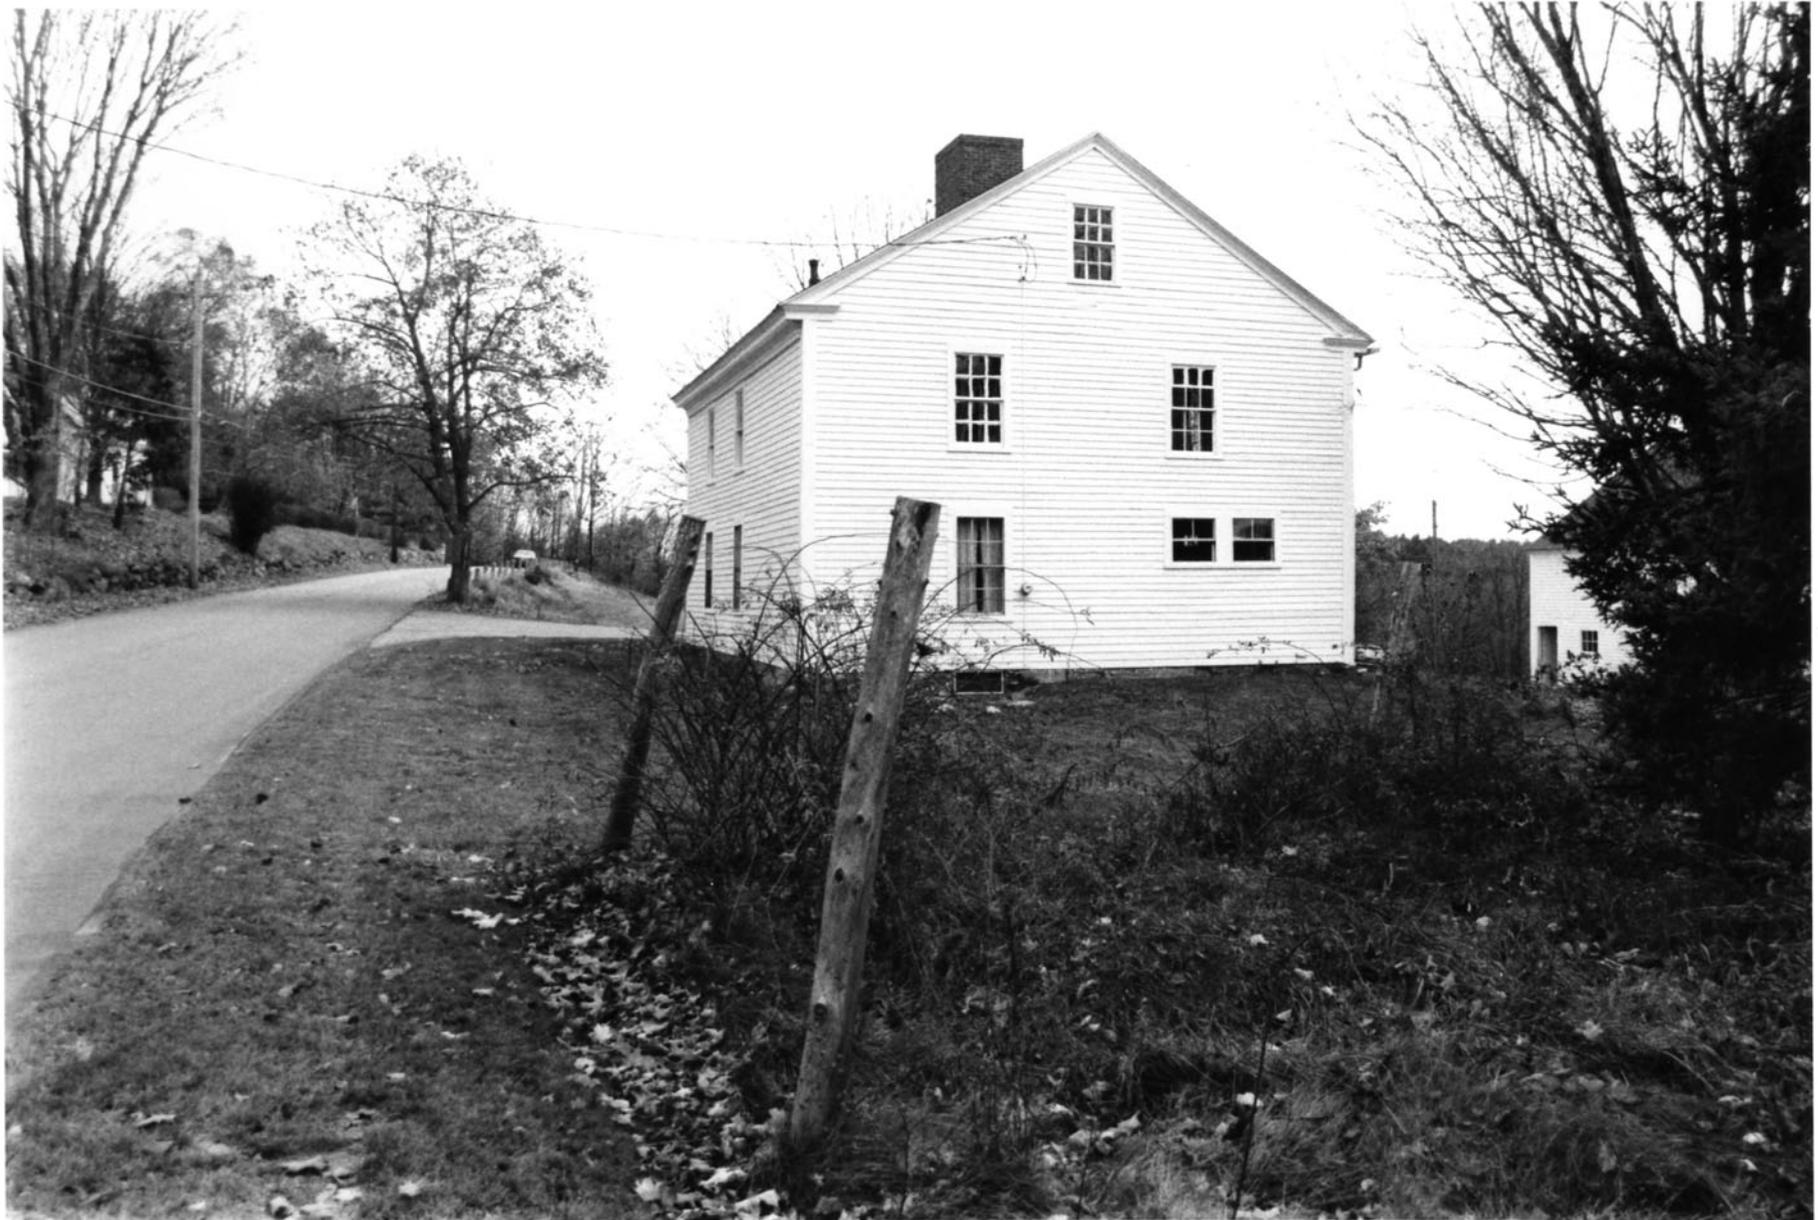
4. Levi Wetherbee House, mid-18th C./ca. 1800-1815: looking east, with north and west elevations (Photographer: Anne Forbes, 2004)

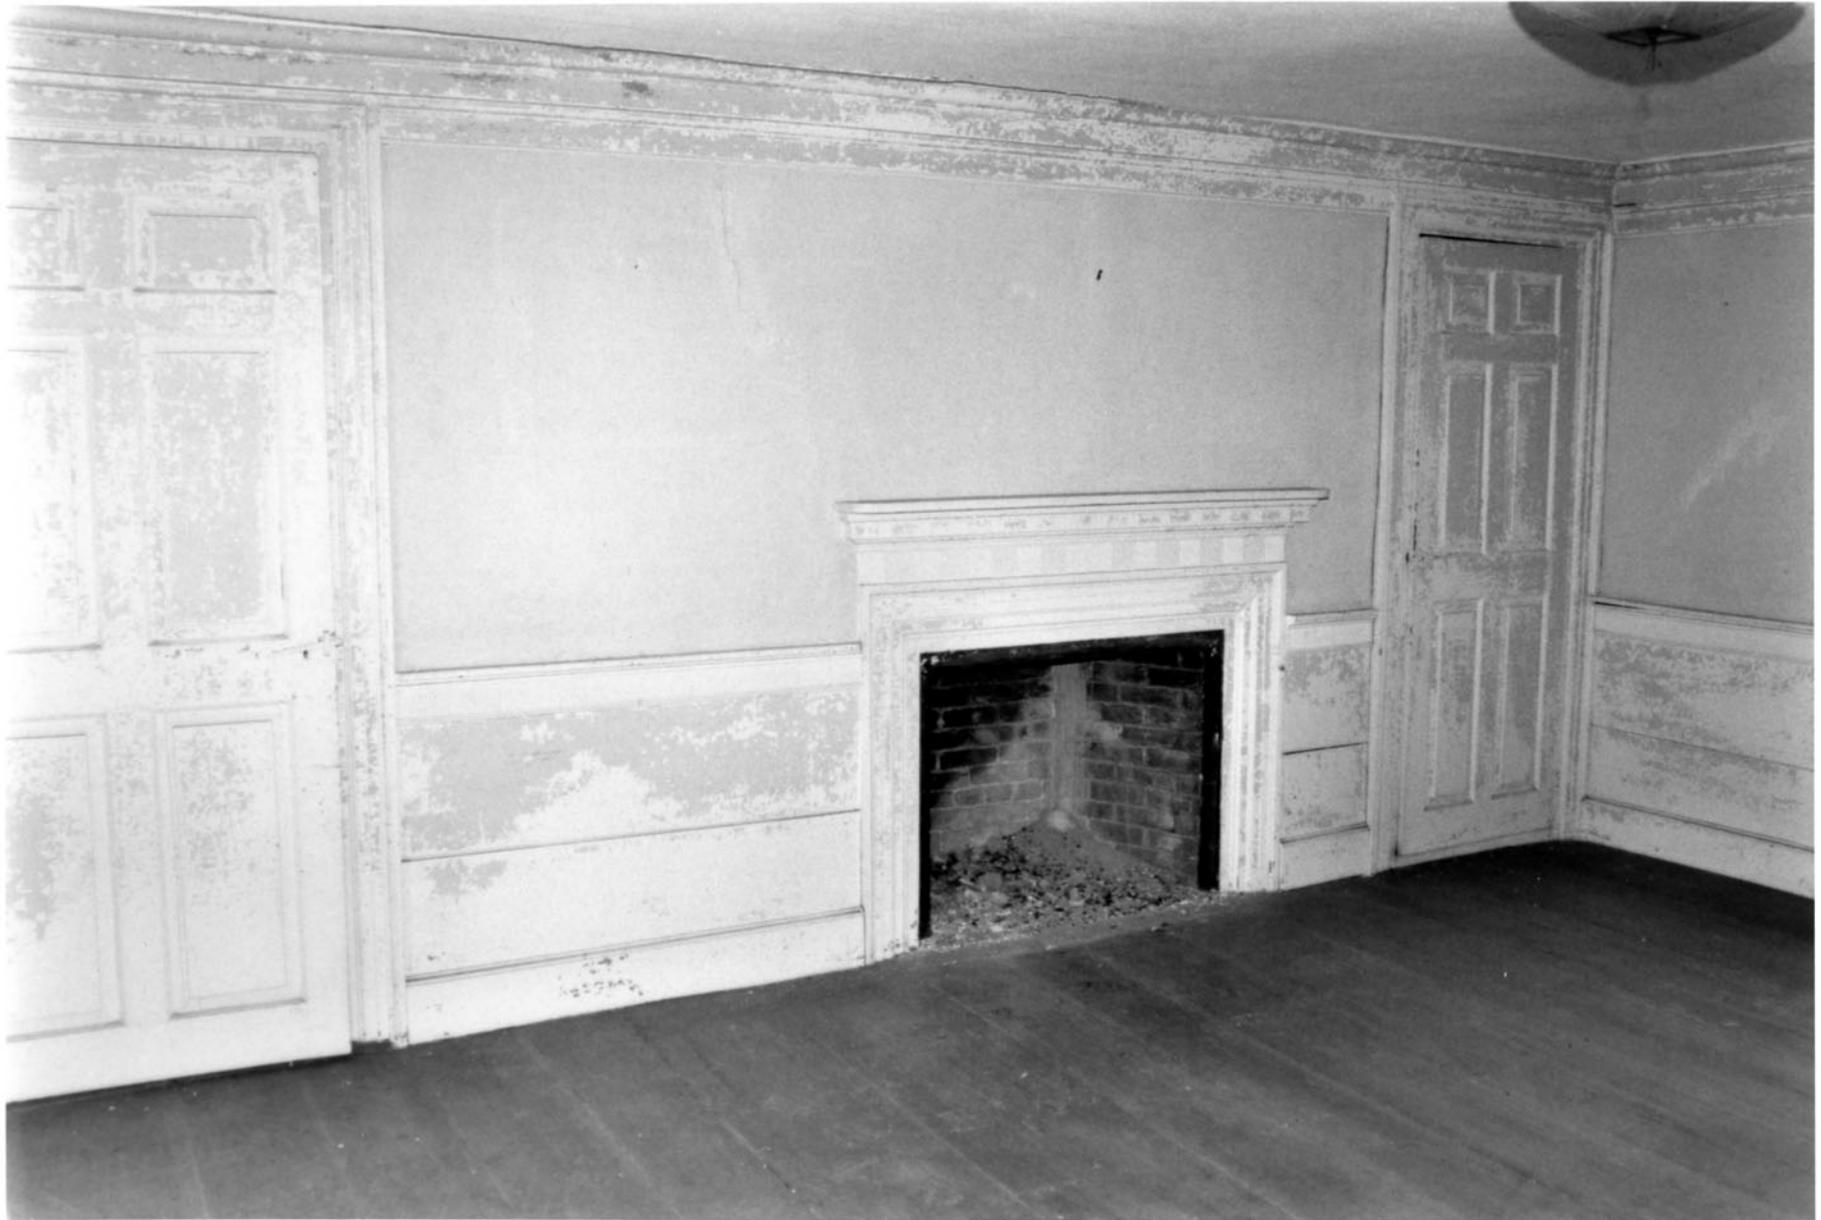
5. Levi Wetherbee House, mid-18th C./ca. 1800-1815: southeast chamber: fireplace wall (Photographer: Anne Forbes, 2004)

The southeast chamber is the most stylish room in the house, with an even larger and more elaborate cornice than that in the southwest chamber. (Photo 5.) The walls are ringed with a beaded-board dado trimmed with a molded baseboard at the bottom and a line of finely-carved vertical reeding under a molded chair rail at the top. The mantelpiece of the small brick fireplace is an outstanding example of Federal-style carving. The frieze is decorated with squares of alternating vertical and horizontal reeding, and above it is a line of vertical reeding under a simple mantel shelf. The molding of the fireplace surround matches that at the doorways.

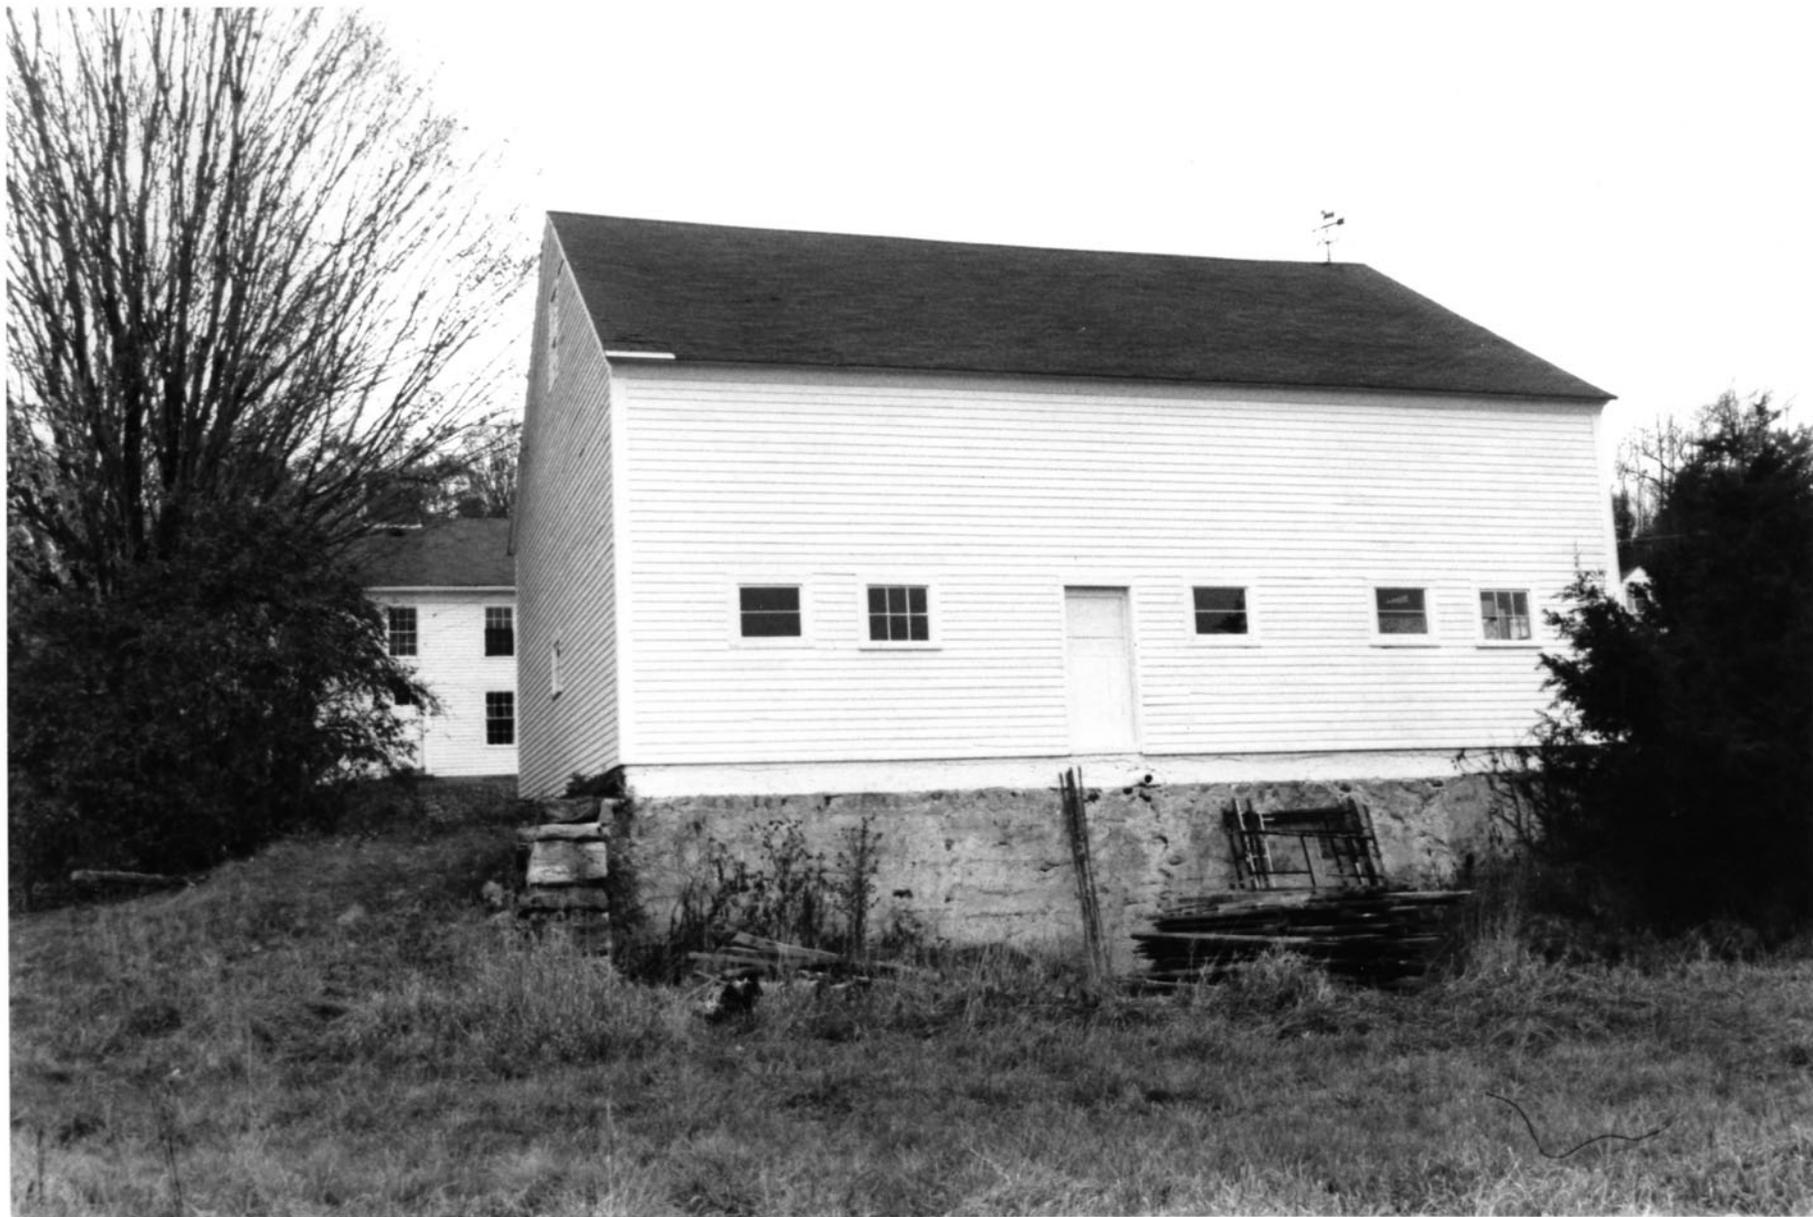
6. Levi Wetherbee Farm: Steele Barn (1941), with farmhouse in background, looking north (Photographer: Anne Forbes, 2004)

**Steele Barn** 1941 (MHC #4; Map #2, Photos 1, 3, 6.) Thomas A. Steele, builder.

The 36' x 42' barn, originally built as an apple barn, stands with its main gable facing the short driveway which runs past the east end of the house from Middle Road. The building is of stud construction utilizing modern dimensioned lumber, and is sided with clapboard. The gabled roof is asphalt shingle; the foundation is largely concrete and fieldstone.

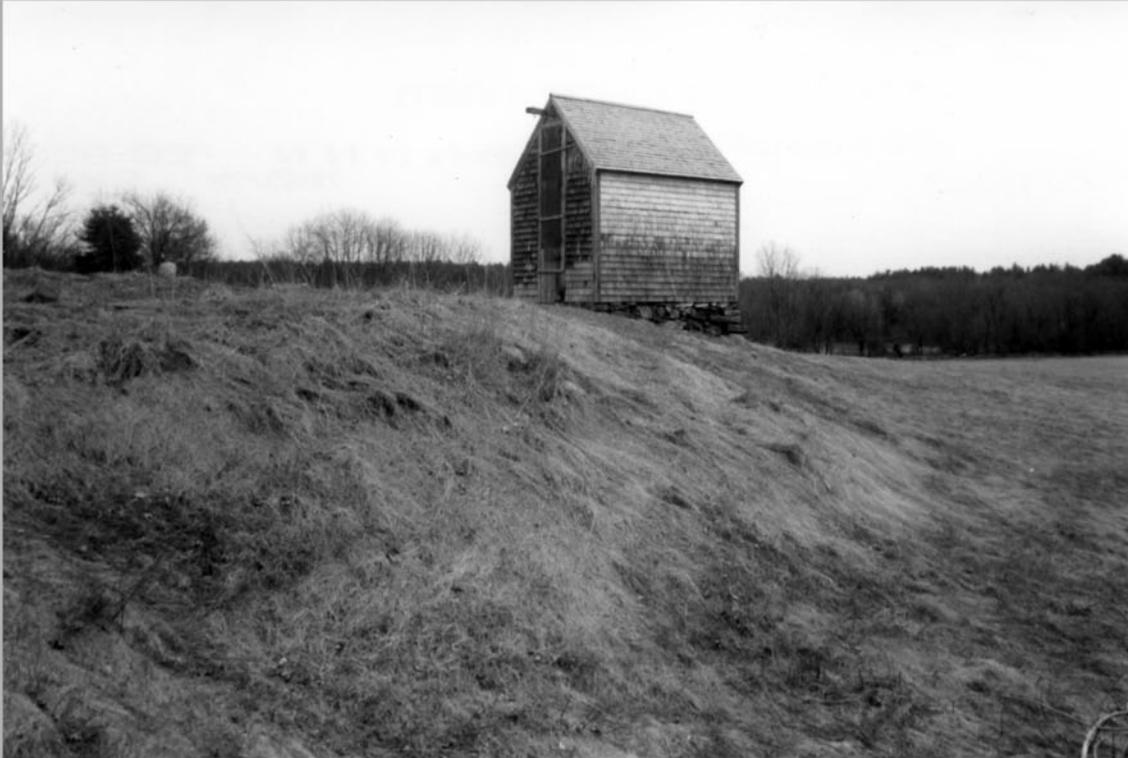
7. View southeast over hay field, with Richardson ice house, (ca. 1904)  
(Photographer: Anne Forbes, 2004)

**Richardson Icehouse**, ca. 1904 (MHC #5, Map #3, Photos 1 and 7.)

In the late 1990s, volunteers from the Boxborough Historical Society dismantled a small ca. 1904 gable-roofed icehouse on the George Richardson Farm on Stow Road, and reassembled it on this property. It stands now in the position where a shed of about the same size stood in the 1940s and '50s. During the process of reconstruction, about two feet of the lower posts and walls had to be removed due to deterioration. The outer walls are clad in wood shingles, some of which still bear their red paint. After the building was moved the roofing was replaced with wood shingles; and the west side wall was rebuilt. Typical of an icehouse, the little building had inner walls of chestnut boards nailed to the inside of the studs. Those boards are presently stored in the barn, awaiting reinstallation. Also typical of a turn-of-the-century icehouse, the building has no windows, and there are three narrow, vertical-board doors, one above the other, in the center of the north gable-end wall. Projecting above them at the gable peak is a horizontal bracket attached to the ridge pole, where the hoist for the ice blocks was mounted. Despite being recently moved, the icehouse retains its integrity and contributes to the nomination as an example of a type of building that was once found on this property.

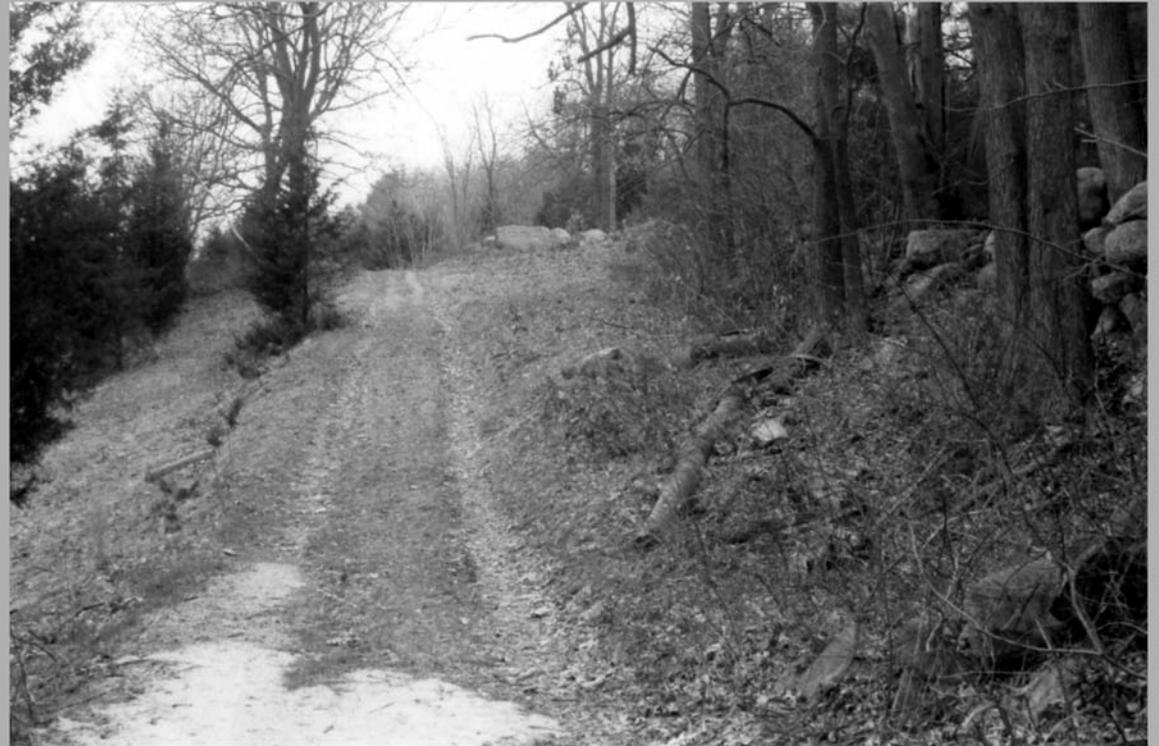
8. West cart path, looking south (Photographer: Anne Forbes, 2004)

On higher ground along the west edge of the property, roughly paralleling the stream, is a heavily rutted cart path (Map #6; Photo 8). The path is intersected at two points by fieldstone walls that may once have formed part an enclosure, although currently openings in the walls, once perhaps fitted with wooden gates, stand open.

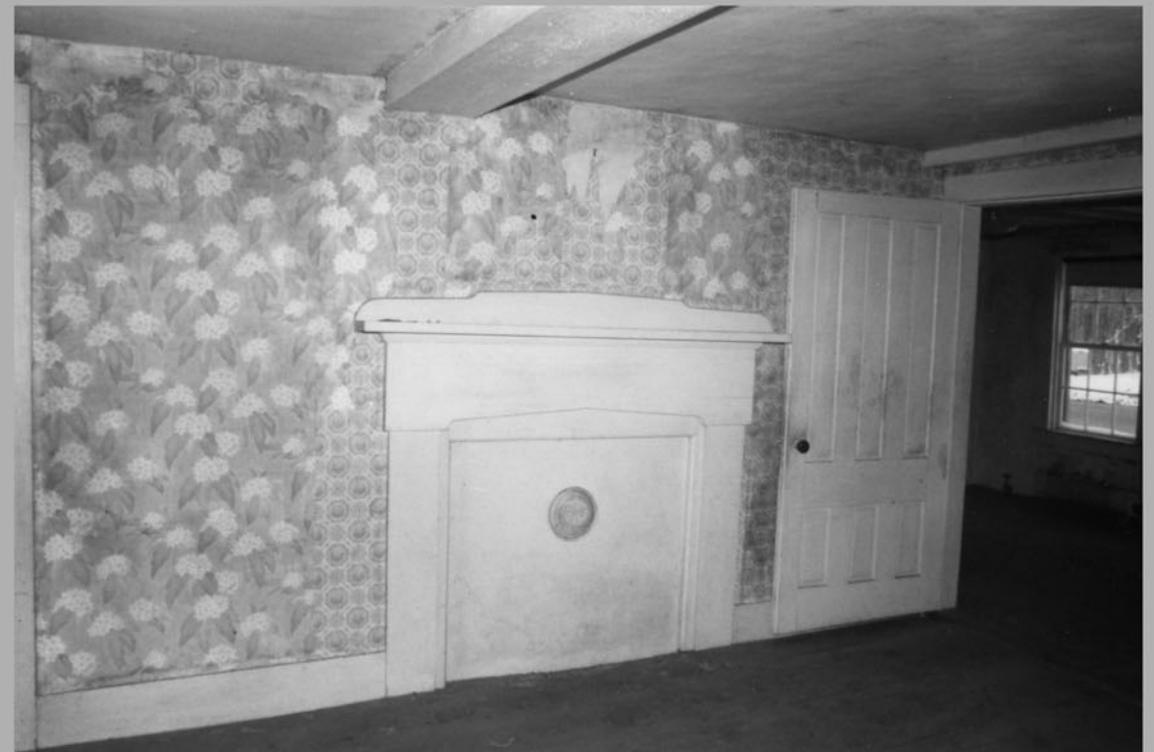
10. Southeast parlor: fireplace wall (Photographer: Anne Forbes, 2004)

In the southeast parlor, the fireplace was blocked in for a stovepipe and the trim updated toward the middle of the 19<sup>th</sup> century. (Photo 10.) Its mantelpiece is a simple composition of very wide boards, including a broad frieze and a thick mantel shelf backed by a low board with a raised center section, which probably indicates a remodeling date between 1830 and 1860. A wide doorway with a pair of 3/3 paneled doors in the north wall of the parlor appears to be an alteration of the early 20th century.

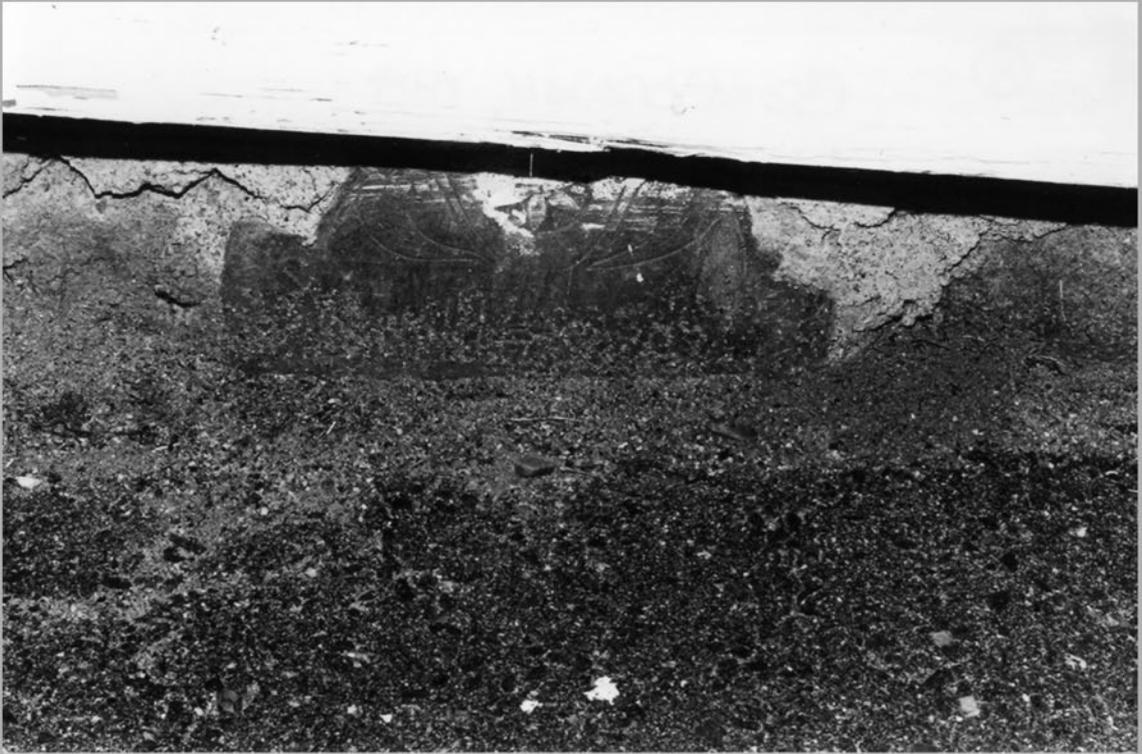
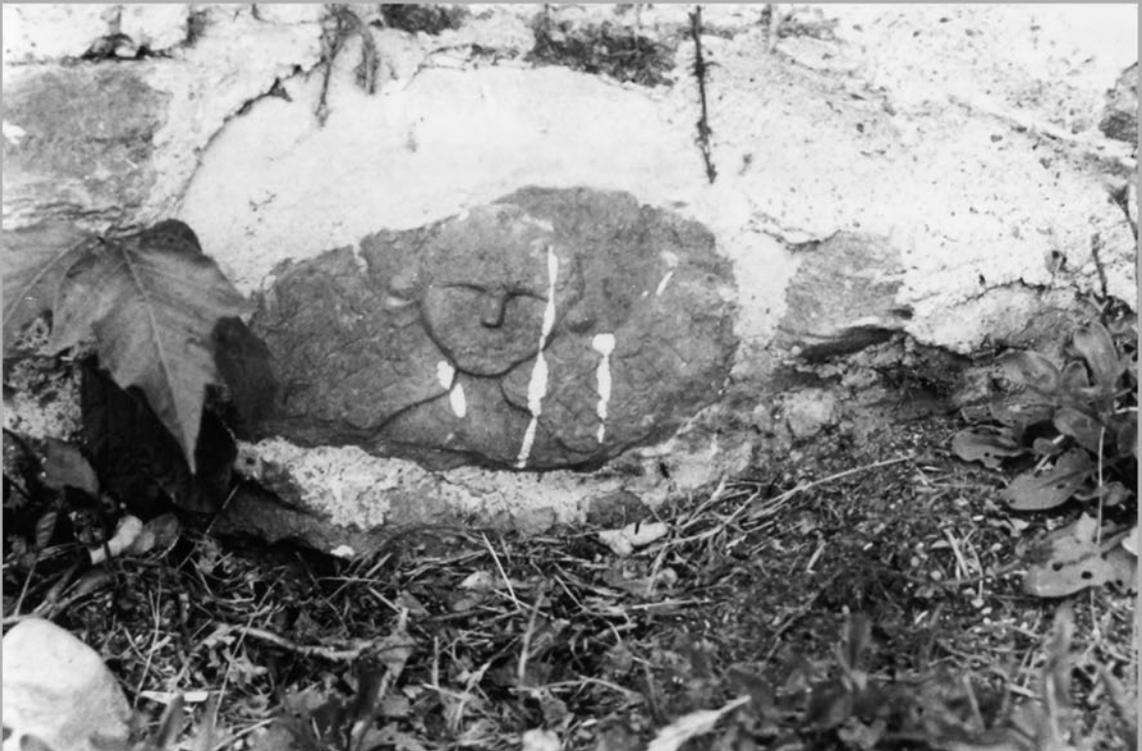
Gravestones in east barn foundation wall

14. North gravestone (Photographer: Anne Forbes, 2006)

15. South gravestone (Photographer: Anne Forbes, 2006)

The east wall of the foundation incorporates the upper portion of two small slate 18th-century gravestones (Map #11; Photos 14 and 15) reported to be from two Wetherbee family graves in the North Burying Ground. According to local residents, the two markers were among the stones displaced by the 1938 hurricane, and were brought onto the property by the Steeles. Both are small shouldered stones, about 9 inches wide. The northernmost is decorated with a schematic sunflower motif, set into a circle, in the tympanum and on each shoulder. The other stone, located south of the doorway, has an expertly carved cherub or angel's head flanked by wings. No inscriptions are visible on either stone.
